**PHASE I ENVIRONMENTAL SITE ASSESSMENT
OF
CRYSTAL SCHOOL
100 Cordelia Street
Suisun City, Solano County, California
For
MAIN STREET WEST PARTNERS**

30 May 2006

SUBSURFACE INVESTIGATION REPORT

**FORMER CRYSTAL MIDDLE SCHOOL
SUISUN CITY, CALIFORNIA**

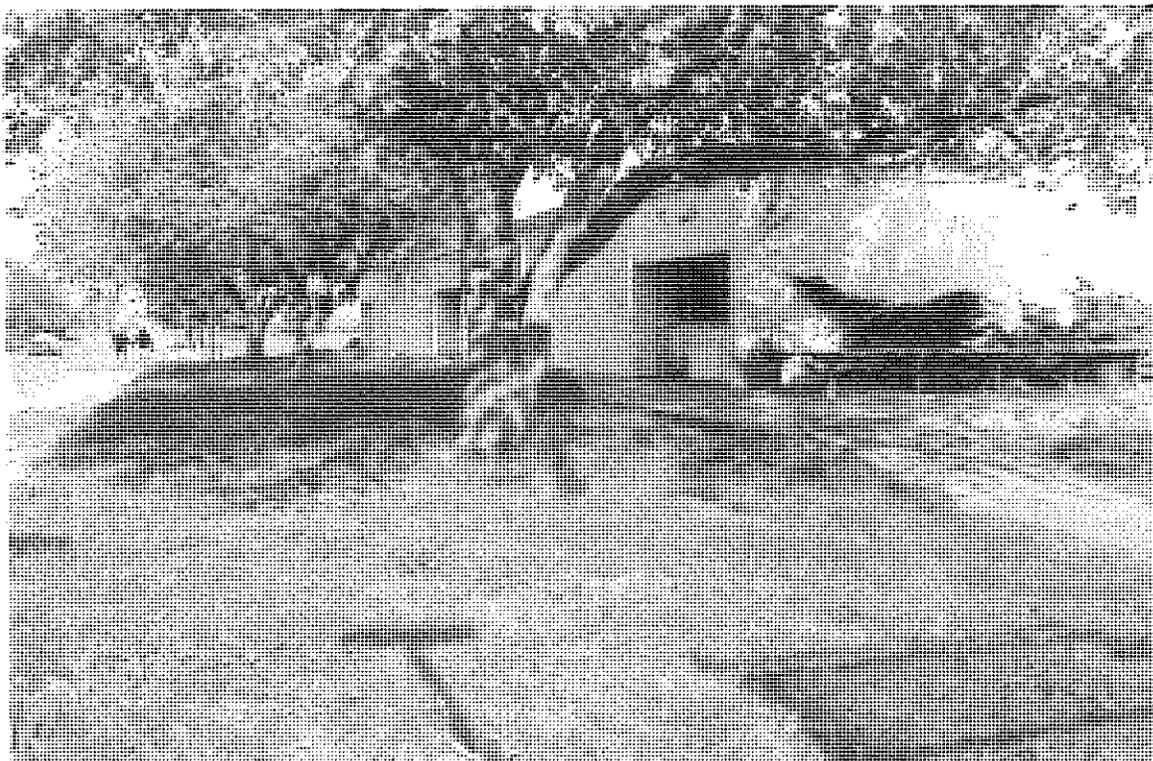
Photo 1. West-facing view from the southeast corner of the property.

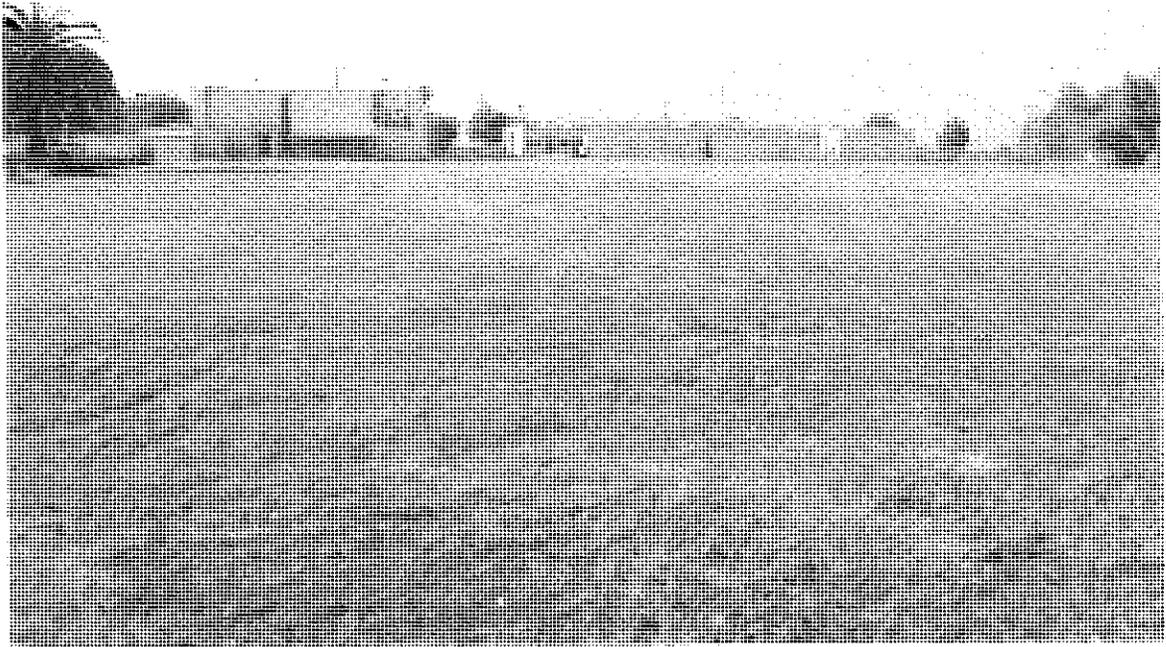
Photo 3. South-facing view from the northwest portion of the property.

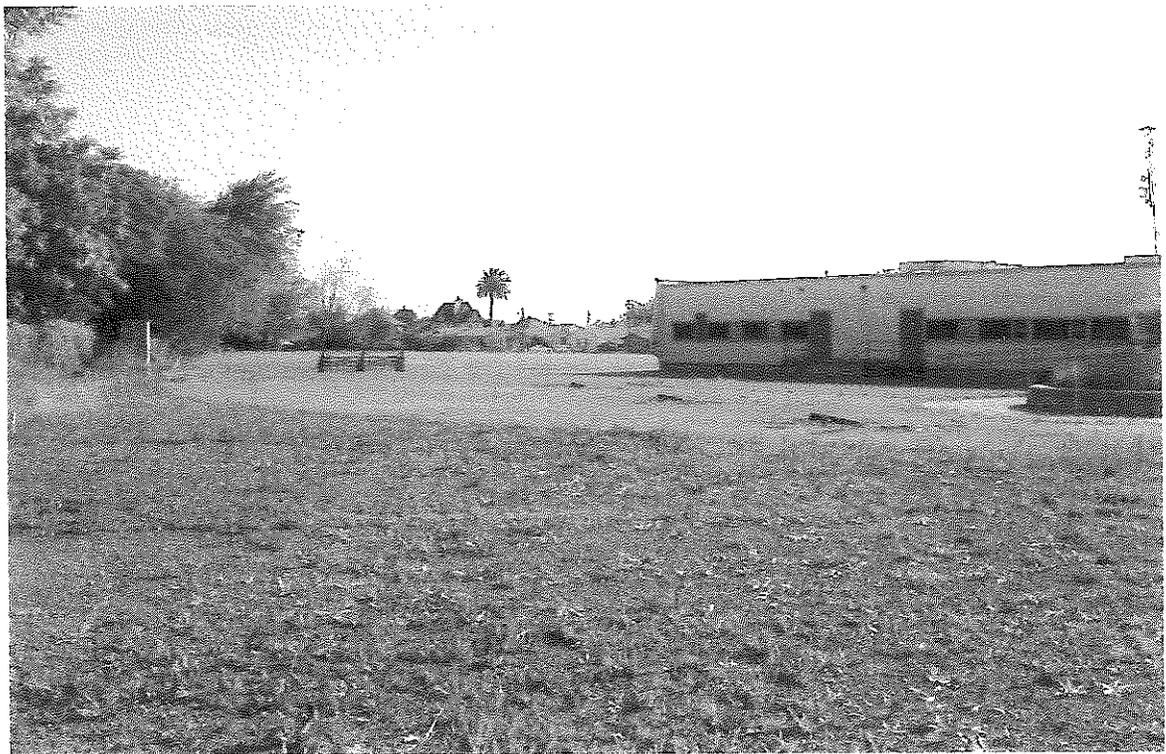
Photo 4. Northeast-facing view from the southwest corner of the property.

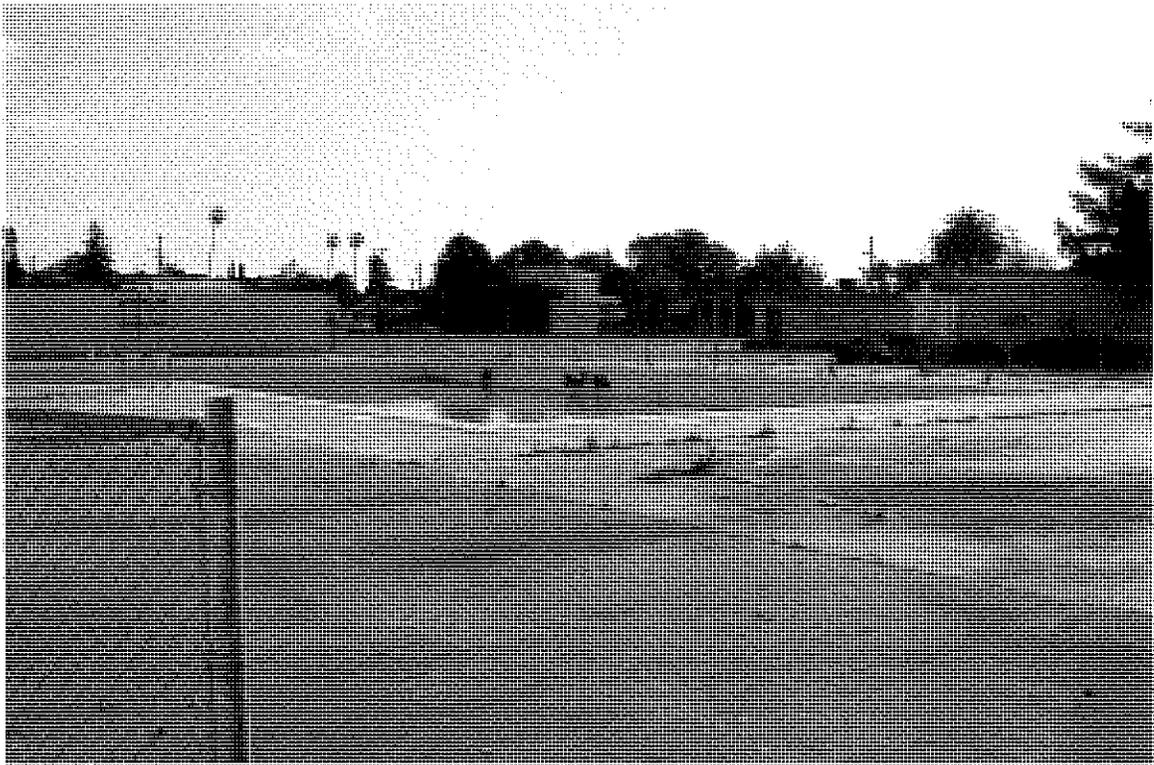
Photo 5. Northeast-facing view of the swimming pool.

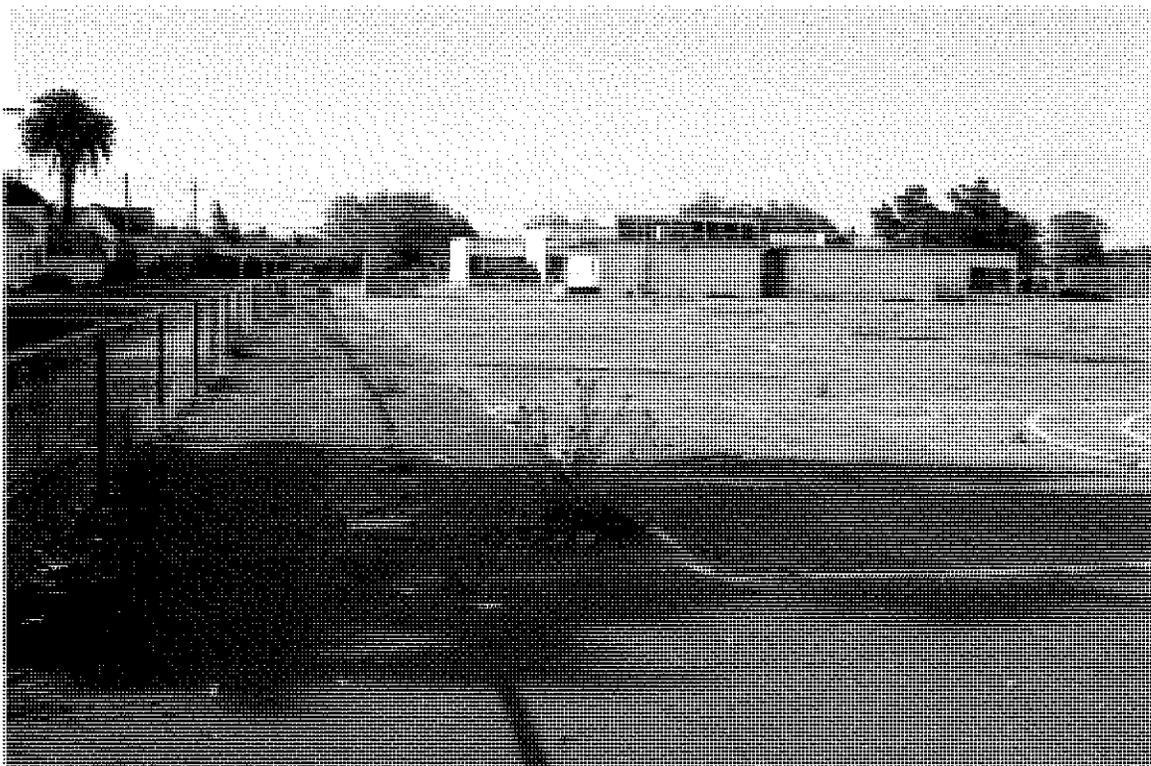
Photo 6. South-facing view from the northeast corner of the property.

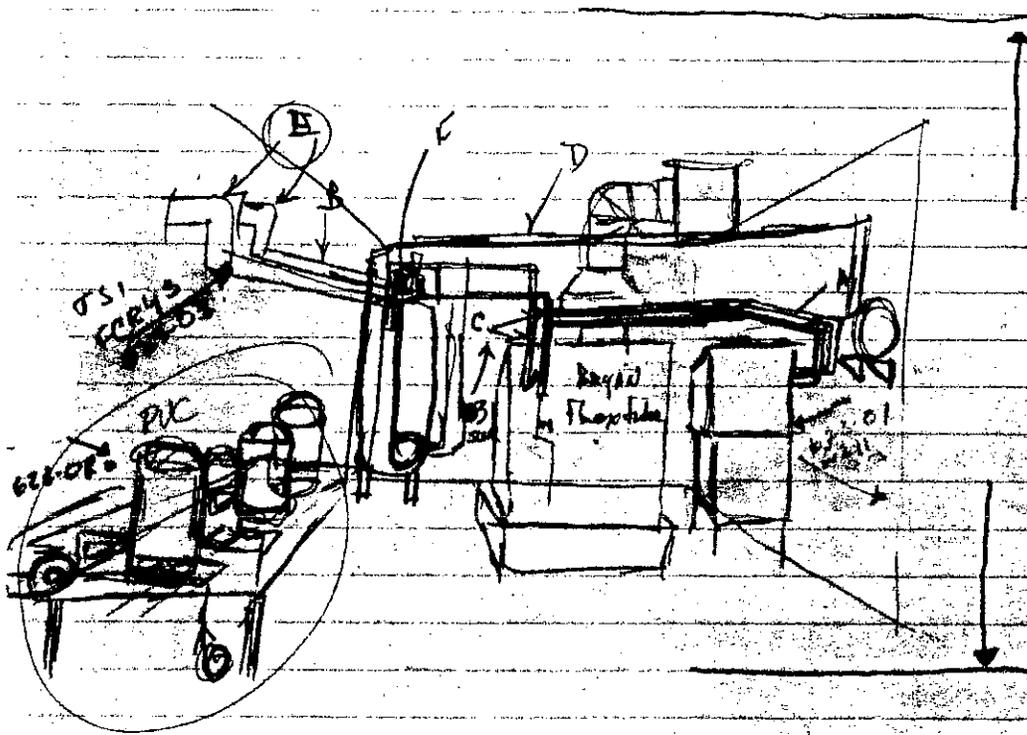
Pool Water Room

- A - Foam rubber insulation
- B - Fiberglass wrapped 2"
- C - Foam insulated 2" copper
- D - Uninsulated 2" C.I. pipe
- E - Hard packed Elbow 2"
- F - glass wrapped Tee 1"
- G. FOAM RUBBER PIPE COVER 63'
- H. ELBOWS HARD PACK 7 TONS
- I. GLASS RAP 93' GRANULES
- J. BOILER RM (CHLOE) ^{ASBESTOS} FREE

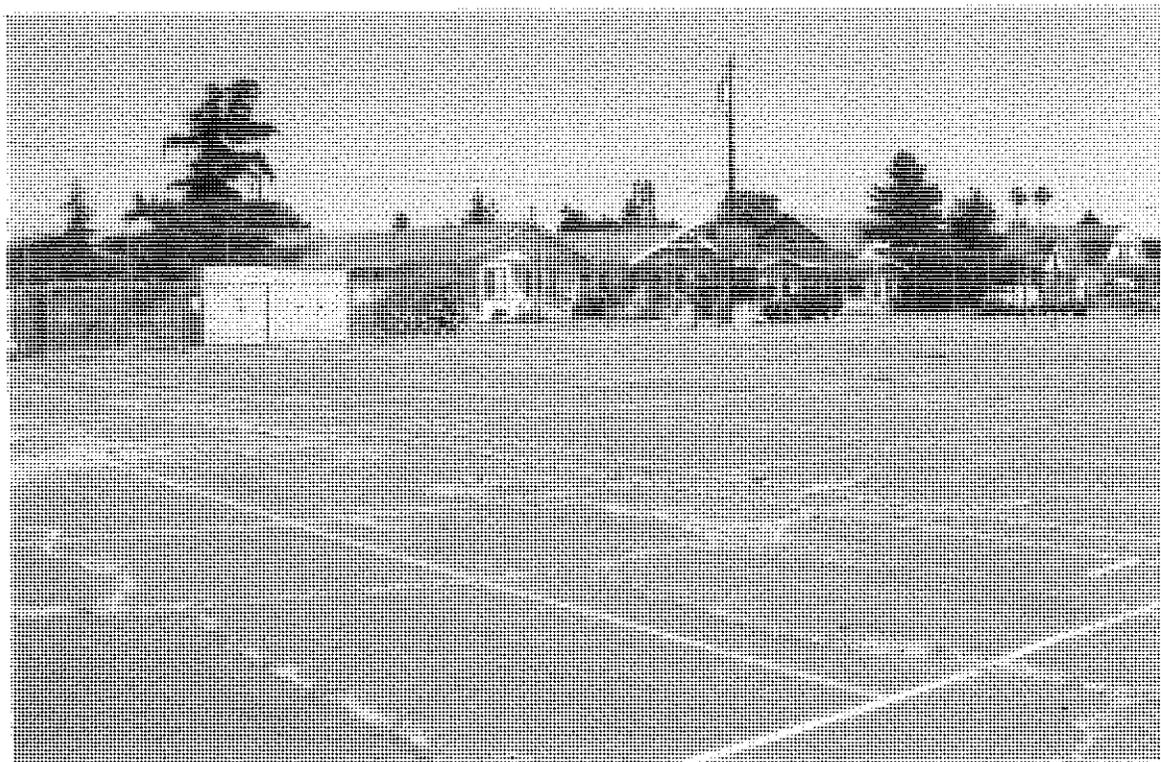
Photo 1. Northeast-facing view of the area surveyed.

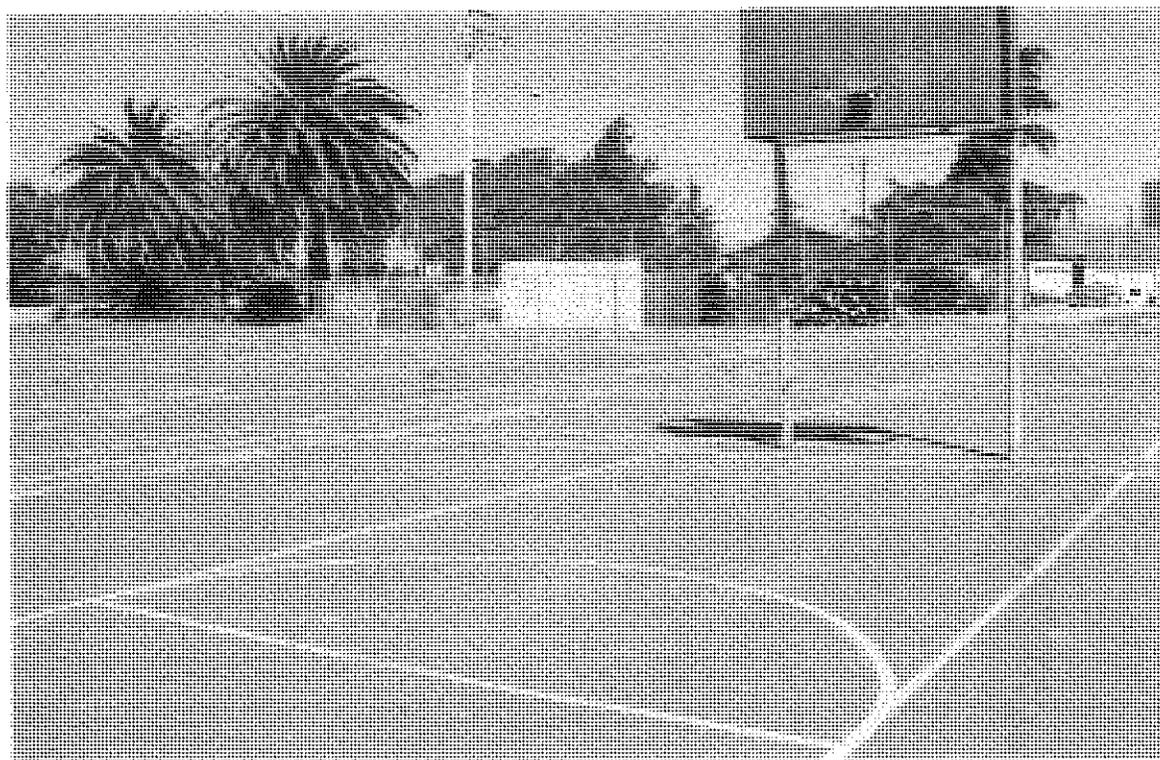
Photo 2. Northwest-facing view of the area surveyed.
