CONTINENTAL APARTMENTS

1101 Crystal Street, 1117 School Street & 1101 West Street
Suisun City, California 94585

Attached please find *Basis Architecture & Consulting Inc.'s (BASIS), PHYSICAL NEEDS ASSESSMENT* (the *Report*) for the above-mentioned asset (the *Property*). During the property investigation and research, *BASIS'* property surveyor met with agents representing the *Property*, or agents of the owner, and reviewed the property and its history. The *Report* was completed according to the terms and conditions authorized by you.

Continental Apartments, Suisun, CA
Conditions as of: November 13, 2012

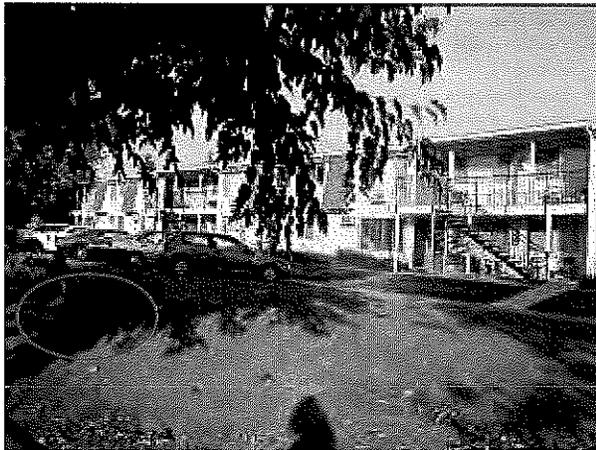
3. View towards 1101 Crystal Street west perimeter; note damaged paving

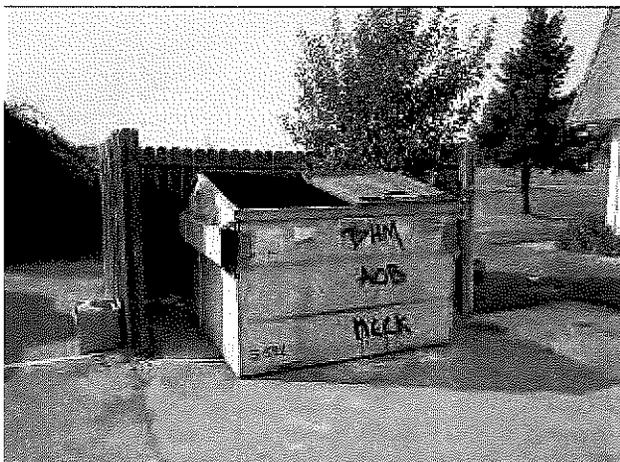
Comments: The wood trash enclosures are showing signs of wear and are anticipated for replacement during the 12 year term.

5. Wood trash enclosure and dumpster at West Street parking area

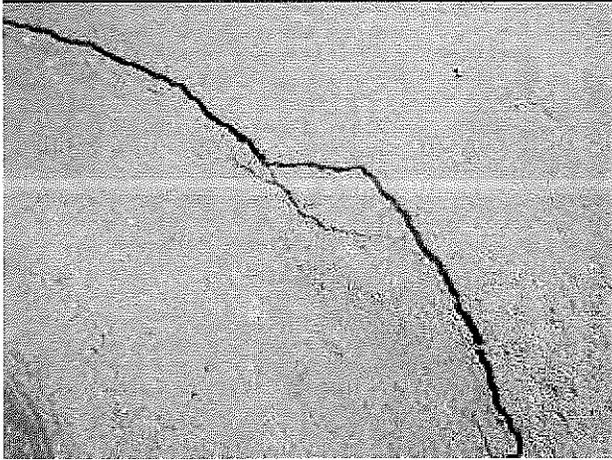
Comments: Overall this system is rated in good to fair condition. Cracking was observed at driveways and parking areas. Repairs and replacements are recommended. Refer to Table 1 for details. Based on the observed conditions and the estimated remaining useful life (RUL) additional paving repairs are anticipated during the 12-year term.

7. Typical asphalt crack noted at the parking areas

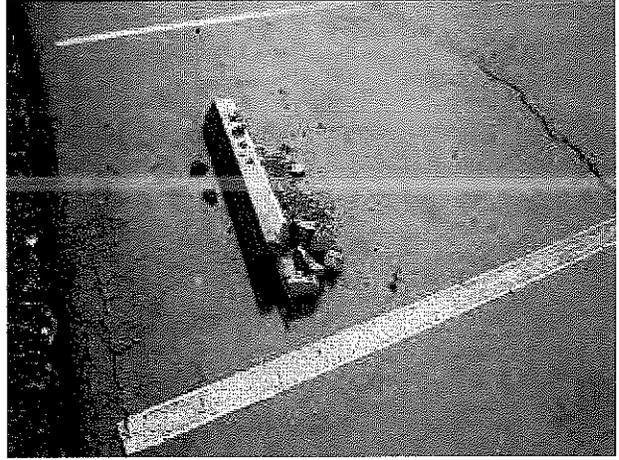
8. Damaged asphalt and concrete wheel stop at open parking area

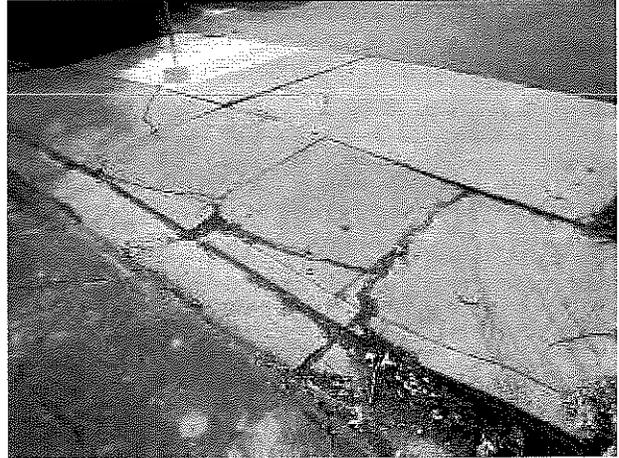
10. Cracked concrete drive apron

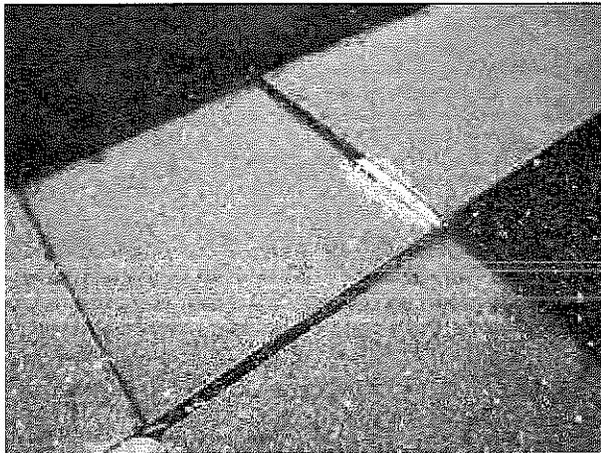
Comments: The sidewalks appear to be in good to fair condition overall. Recent replacements have been required due to settlement and heaving. Additional lifting, cracking and other damage presents trip hazards. Walkway repairs and replacements are recommended. Refer to Table 1. Based on the estimated RUL, additional walkway repairs and replacements are anticipated during the 12-year term.

11. Settled and heaved walkway

Paving	Pedestrian walkway	600	\$3.00	SF		\$1,800	Cracking, settling and other damage was observed at the pedestrian walkway throughout the site. The conditions appear to be due previous settlement. Remove and replace any significantly damaged walkways and seal minor cracks to prevent water intrusion and future settlement. Seal all top hazards were observed. Clean moss growth to prevent slip/fall hazards.
Landscaping	Tree removal/trimming	1	\$5,000	A few		\$5,000	The deep rooting trees may be resulting in the soil settlement along the south portion of the site. Other trees have rotted in heavily walkways in the recent past. Remove a portion of the trees to prevent future walkway damage and soil settlement. Trim any overgrown trees to avoid clogged gutters.
Accessories	Signage	1	\$10,000	A few		\$10,000	Install Property Identification signage of each parcel as well as directional signage throughout the site. Property is hard to locate with current signage provided. Adding minimum sign and additional common area directional signage will assist emergency personnel and the general public to better identify the Property.

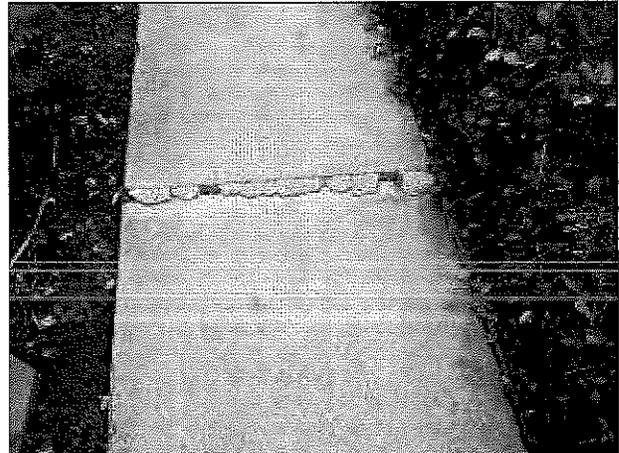
12. Off set / trip hazard at walkway 1101 Crystal

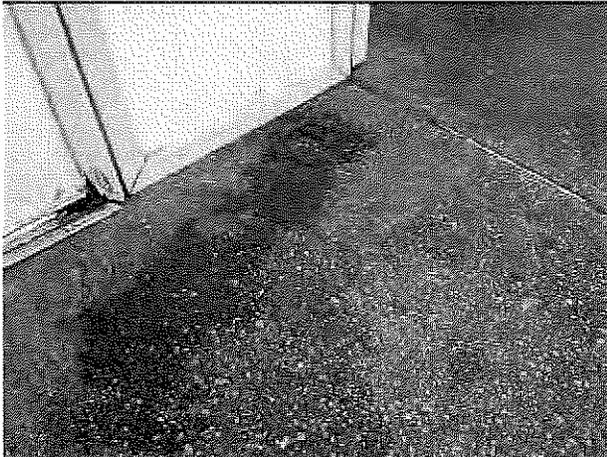
13. Moss growth at walkways; slip hazard. Also note rotted electrical meter enclosure. 1101 West Street; north perimeter

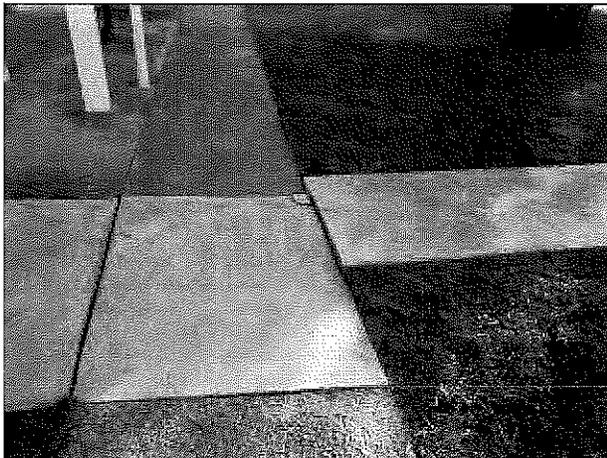
15. Recently replaced walkway at laundry room entrance; additional damage noted

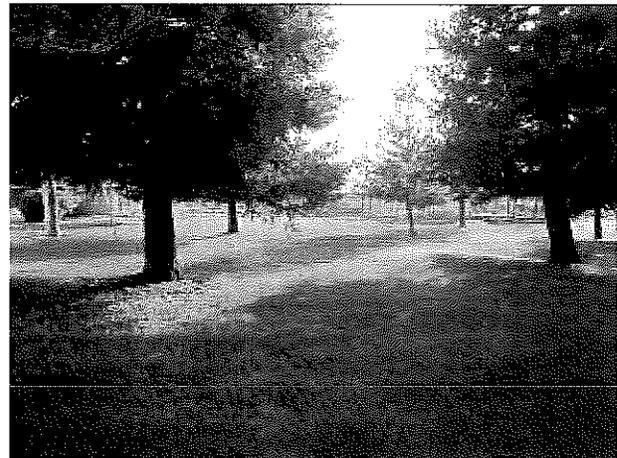
16. Open landscaped areas at the south perimeter of the Crystal Street building. Deep rooting trees are resulting in settlement of soils

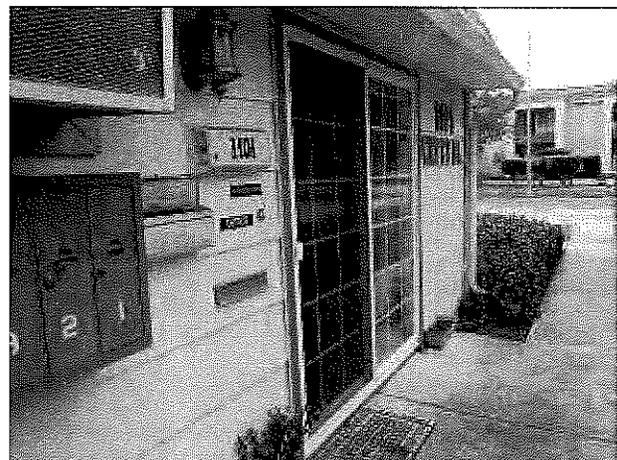
Comments: Aside from normal wear, the observed doors appear to be in good condition and replacements are not anticipated during the term. The entry thresholds and doors at the leasing office and laundry room entrance are non-conforming for accessibility. Refer to Table 1. Based on the estimated RUL, some exterior door replacements are anticipated during the 12-year term.

18. The leasing office entry threshold exceeds allowable limits for accessibility guidelines

Accessibility	Common area elevators	2	\$2,300	Each		\$4,600	The laundry room and office entry thresholds are non-conforming for accessibility guidelines and should be replaced.
MECHANICAL/ELECTRICAL							
Plumbing	Install seismic restraints at water heaters	1	\$500	A few		\$500	Install code conforming seismic restraints at all water heaters. Patch damaged or replace missing drywall at water heater closets to prevent fire stop hazard.
Electrical	Install smoke and carbon monoxide detection	76	\$75	Units		\$5,700	Install carbon monoxide detectors in all units and smoke detectors in all unit bedrooms.
ADA	Audio/visual alarms	1	\$1,000	A few		\$1,000	To better comply with accessibility guidelines, provide the be alarms in the laundry room and office area.
DETAILING COSTS							
					TOTAL	\$11,470	\$393,120
					GRAND TOTAL		\$392,232

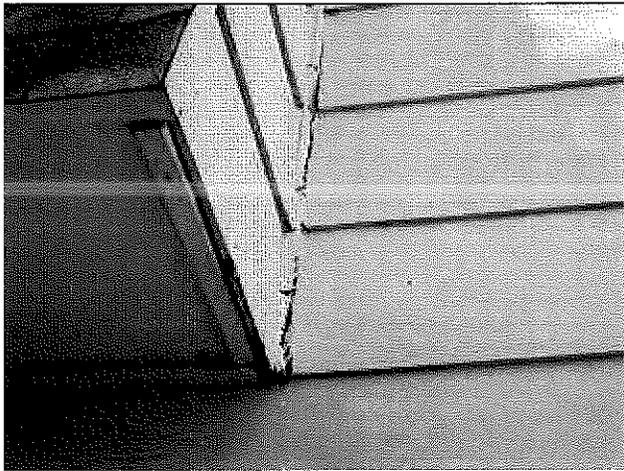
19. Damaged siding and paint at building exteriors

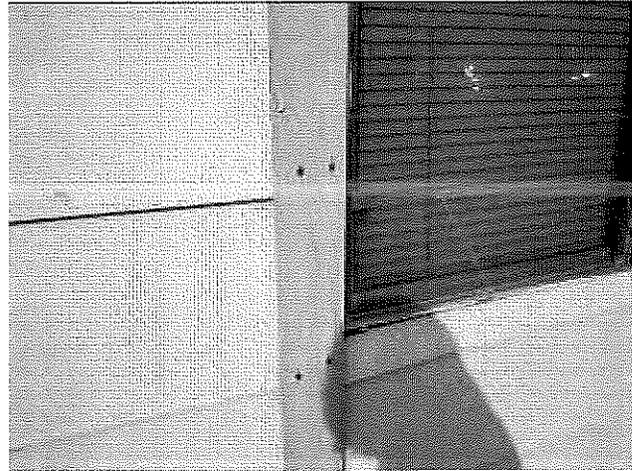
Comments: The estimate of the façade condition is based on representative observed areas of the exterior walls and the age of the improvements. Those portions of the façades observed appear to be in good to fair condition. Damaged siding, trim, dry rot, peeling paint and otherwise damaged components were observed. Refer to Table 1. Replacement Reserves are recommended for exterior painting, during the 12-year term.

20. Damaged siding and paint at building exteriors. Rusted and popping nails indicate water intrusion

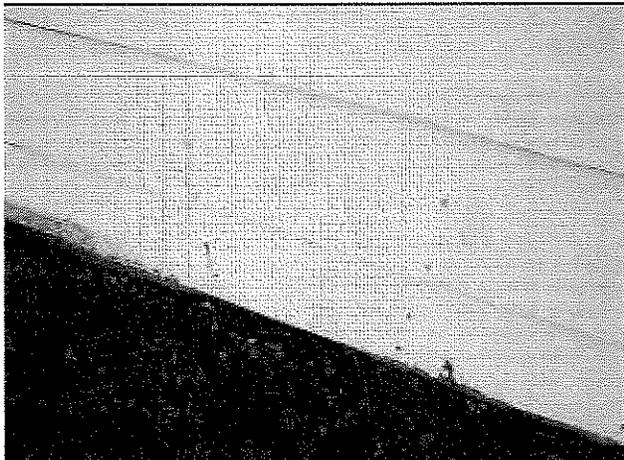
21. Damaged siding, rusted nails and weathered finishes

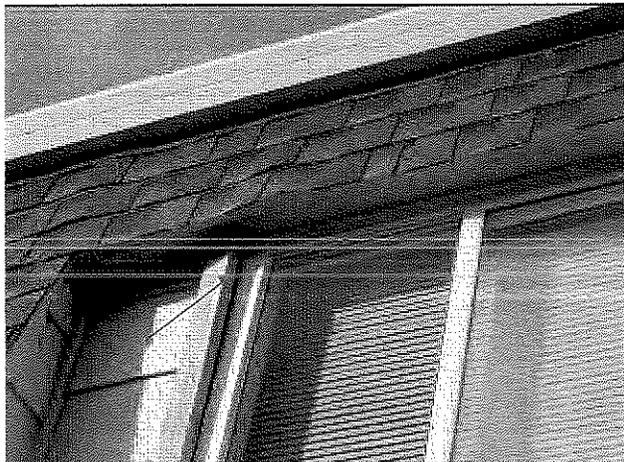
23. Loose shingles, replacement window and loose wood trim

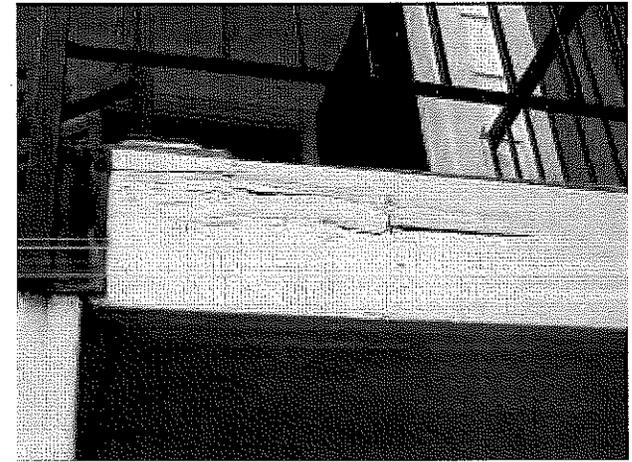
Comments: Cracks at the landings, dry rot damaged landings, and damaged treads were observed at the exterior stairs. Stair upgrades due to non-conforming handrails, open treads that present a trip hazard and lack of contrasting nosings. Stair landing replacements and stair upgrades are recommended. Refer to Table 1. Replacements are not anticipated during the 12-year term.

24. Rotted stair landing at Crystal Street building

Stair Landings	Replace rotted landings	2,200	\$3.00	SF		\$17,600	Evidence of rotted framing, cracking topping or recent repairs were noted at several stair landings and elevated walkways. Survey all structures and replace damaged concrete topping as needed. Replace damaged wood framing as needed. Seal gaps at elevated walkways to prevent water intrusion. Install an elastomeric waterproofing membrane at landings and walkways to prevent future rot and damage.
Finishes/Ort	Wood Deterioration Field Survey	76	\$45.00	Units		\$3,420	Due to the current dry rot damage and previous water intrusion at the stair landings, siding and wood trim elements, a full Wood Deterioration Field survey is recommended for the Property.
Accessibility	Laundry room	1	\$1,000	A few		\$1,000	Reconfigure equipment to provide conforming clearances for wheel chair access at the laundry room interior. Provide one front loading washer and dryer with controls at the front of the equipment for accessibility conformance.

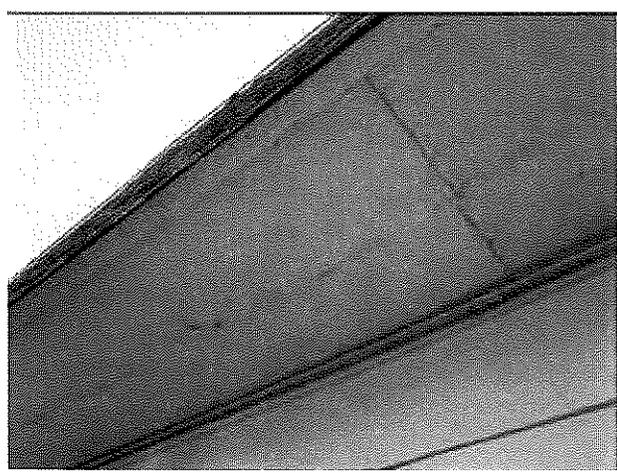
25. Warped siding at soffit area; north façade of School Street building

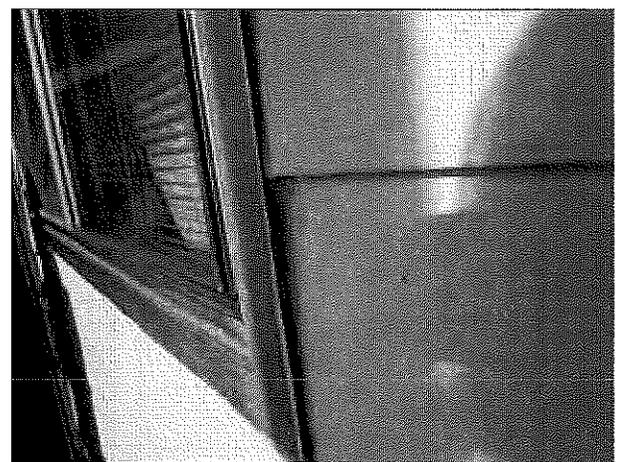
Comments: The original windows are approaching the end of their useful lives as evidenced by the need for recent replacements. Some of the replacement windows appear to have not been installed to code. Refer to Table 1 for details. Based on the age, additional replacements are anticipated during the 12-year term.

27. Gap at siding and retrofit window; west façade of the West Street building

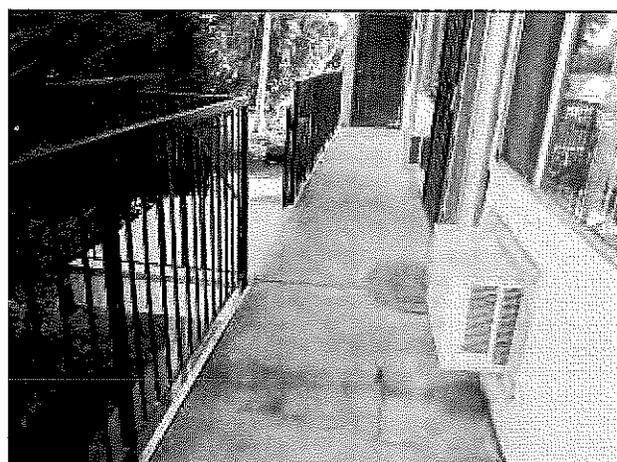
28. Cracked elevated walkway and recently replaced stair landing at the Crystal Street building

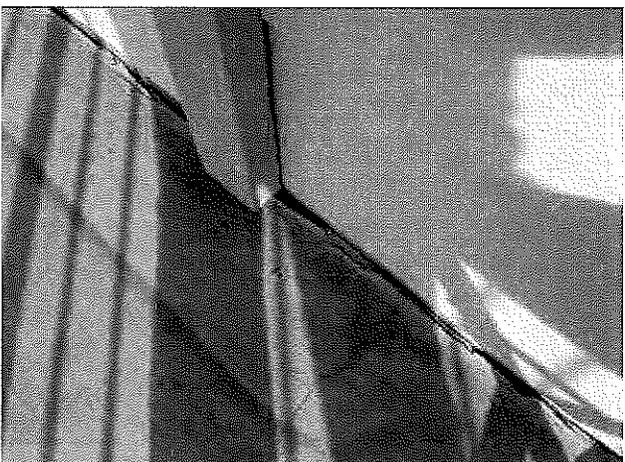
29. Gaps at exterior wall to elevated walkway at west façade of the West Street building

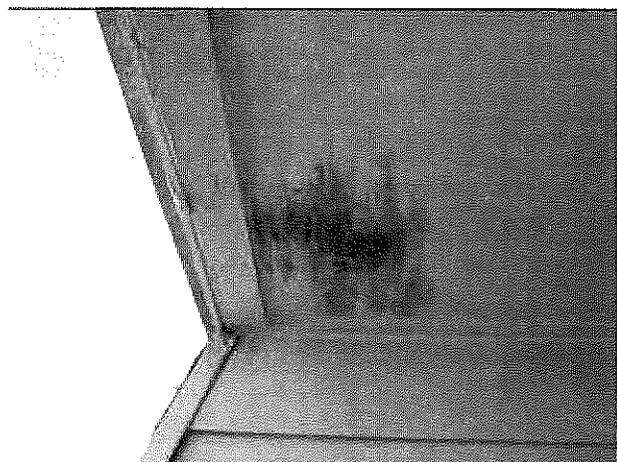
30. Damaged soffit from bat infestation

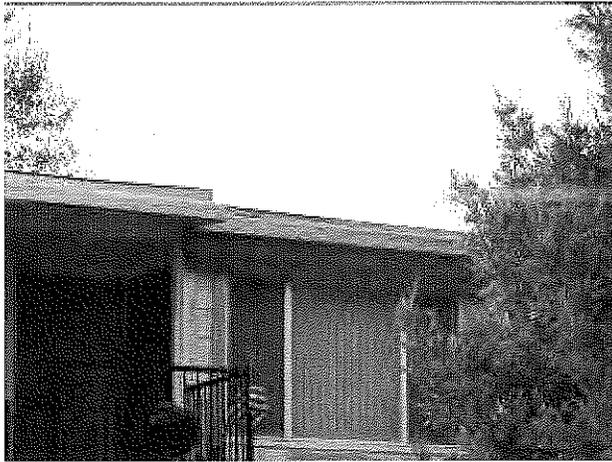
31. Clogged gutter and replaced window

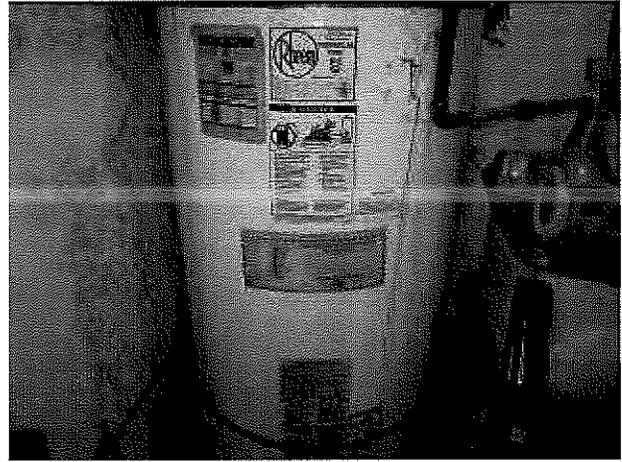
32. Typical gas fired water heater; note seismic restraints are not code conforming

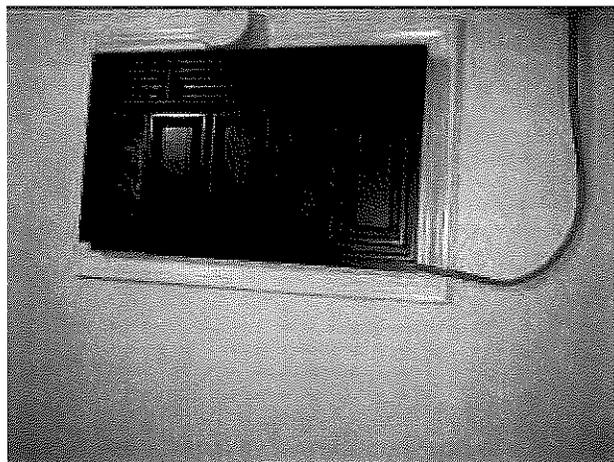
37. Older air conditioner at leasing office

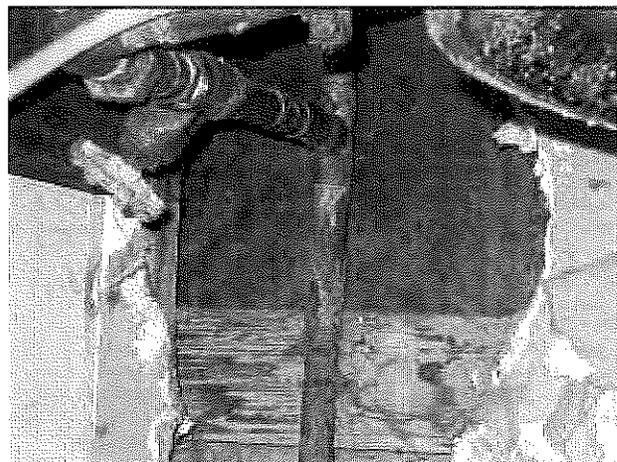
38. Copper water lines and missing drywall in water heater closet

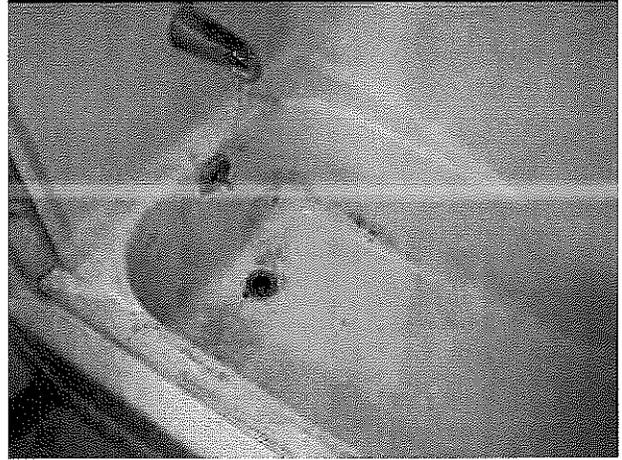
44. Worn tub finishes and older plumbing fixtures
observed in some units

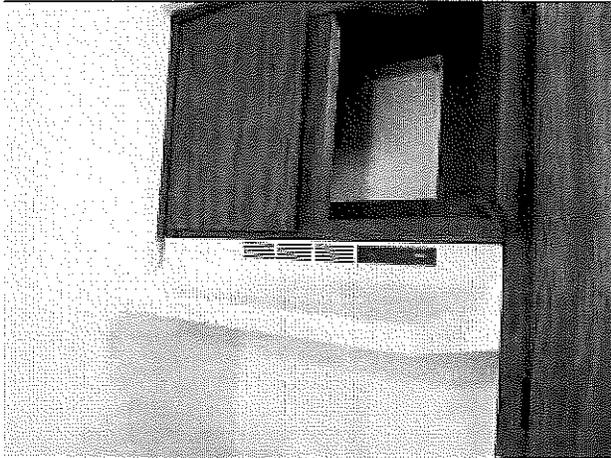
49. Unit range hoods are not vented in some locations
