LAWLER HOUSE

718 MAIN STREET
CURRENT CONDITIONS

The Lawler House was built around 1857, then bought by John Lawler in 1947. Hofmann Company bought the Lawler Ranch in 1976 for a housing development. Sometime afterwards it was moved to Downtown Suisun.

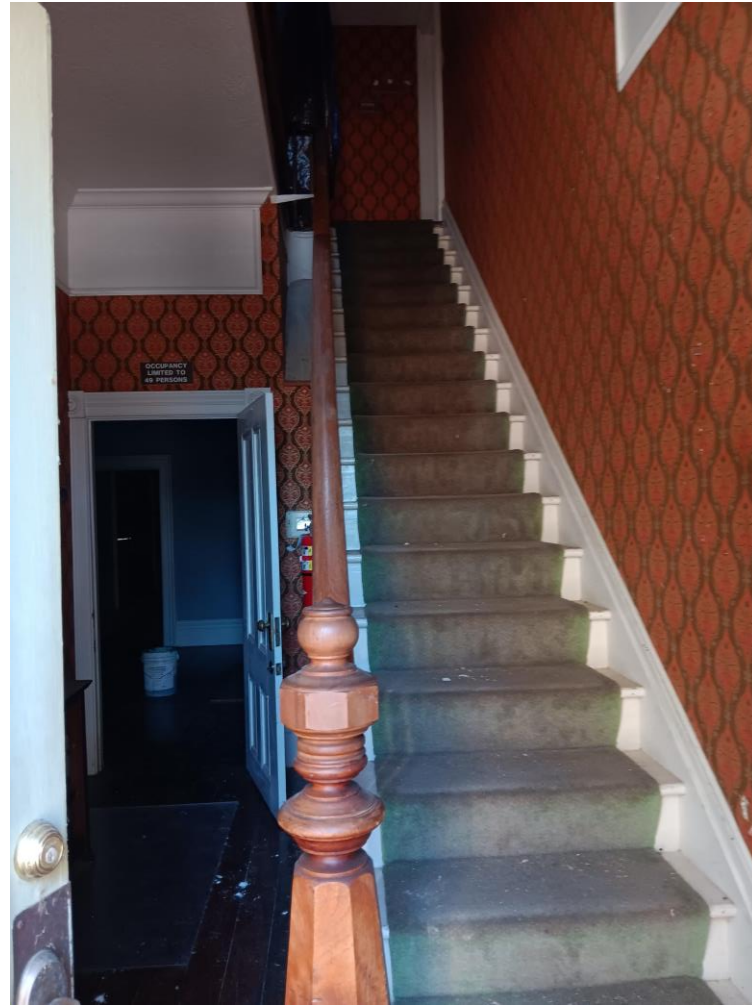
Water damage on stairs

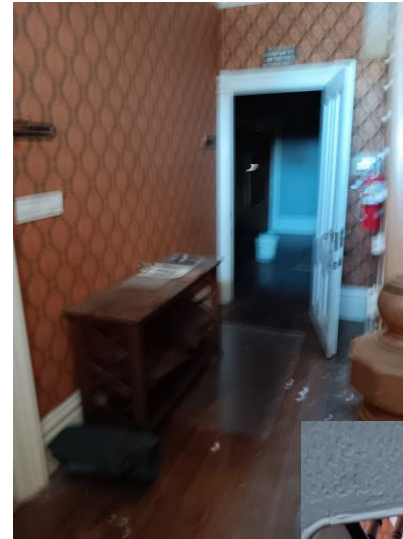
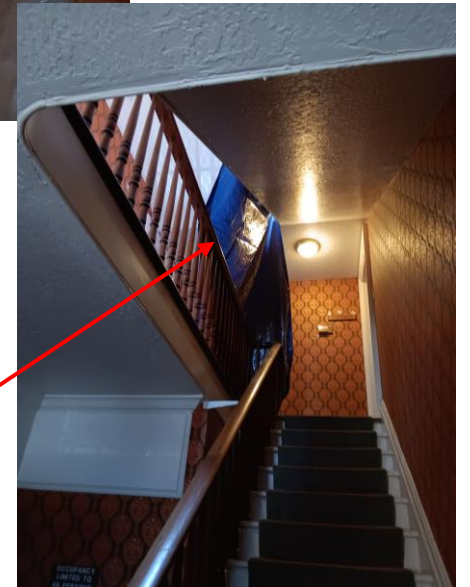
Tarp to
contain water
leaks from
skylight

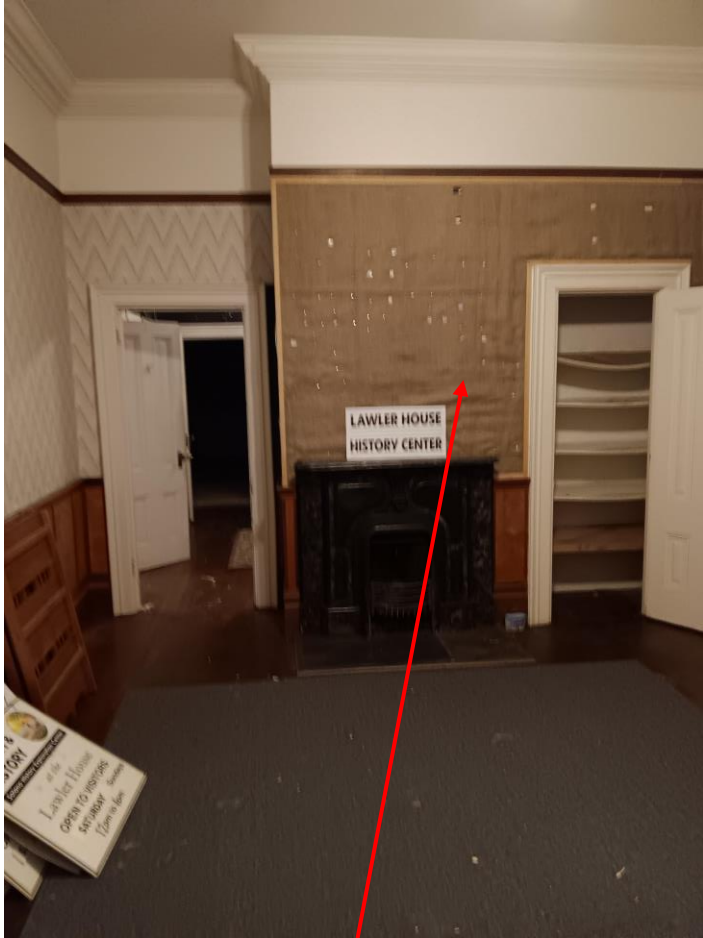
Water leaking down walls

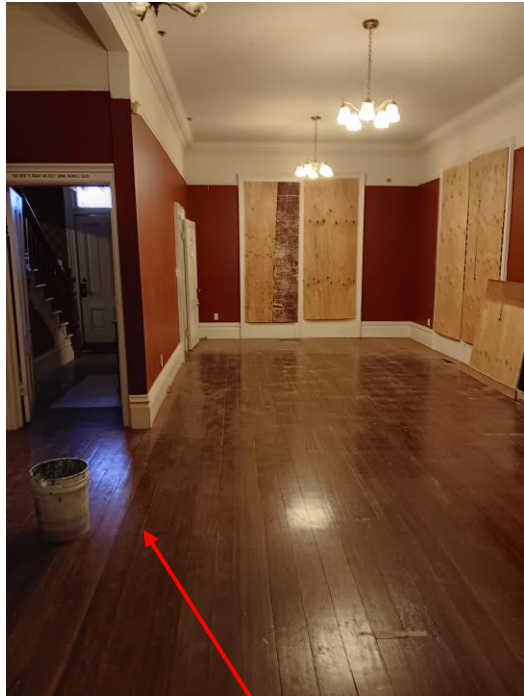
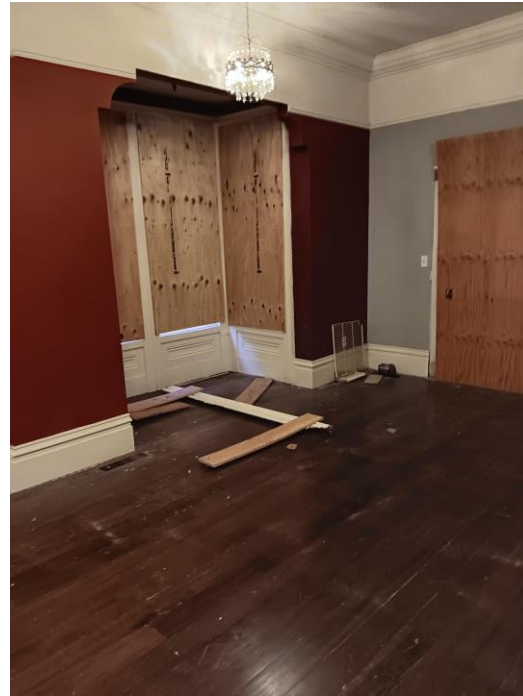
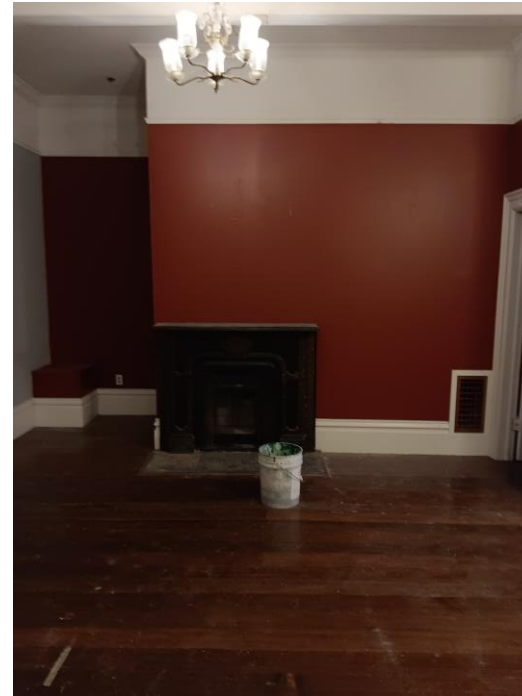
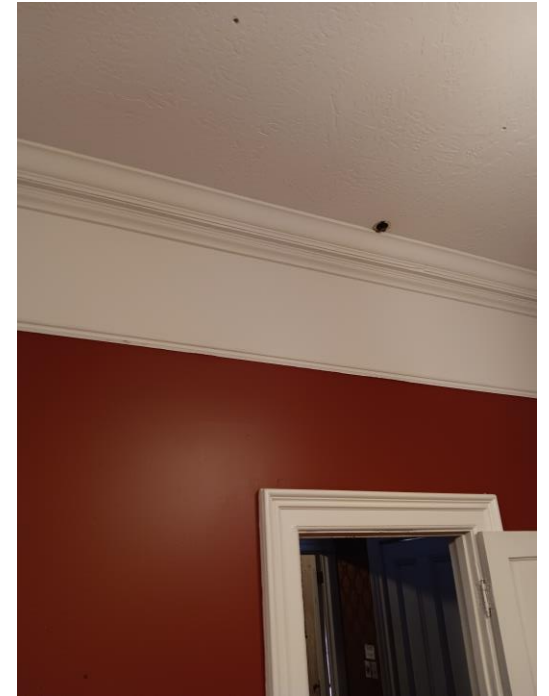
First floor on the left side, Front Room

Water leak from roof damaged floors

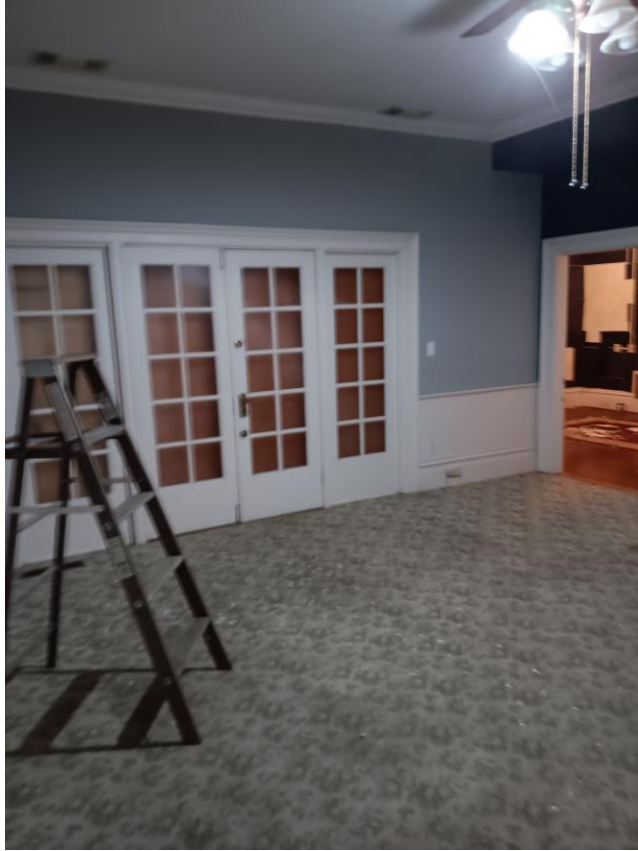
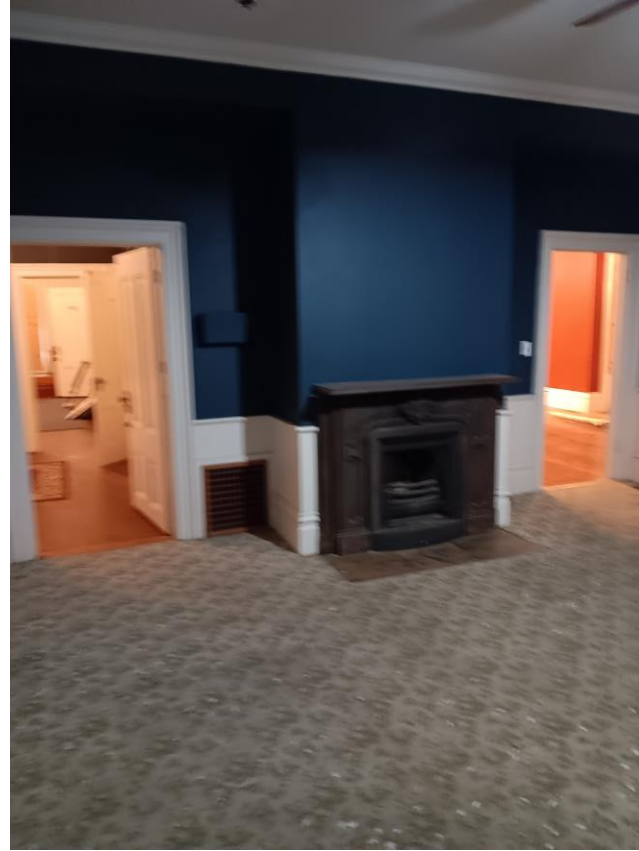
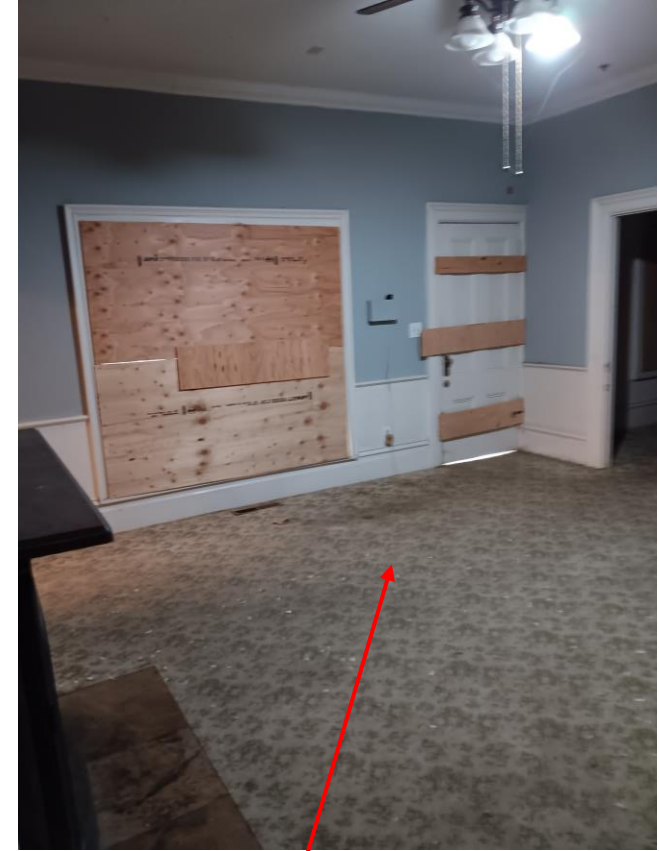
First floor on the left side, Middle Room

Bulging & soft floor from water damage

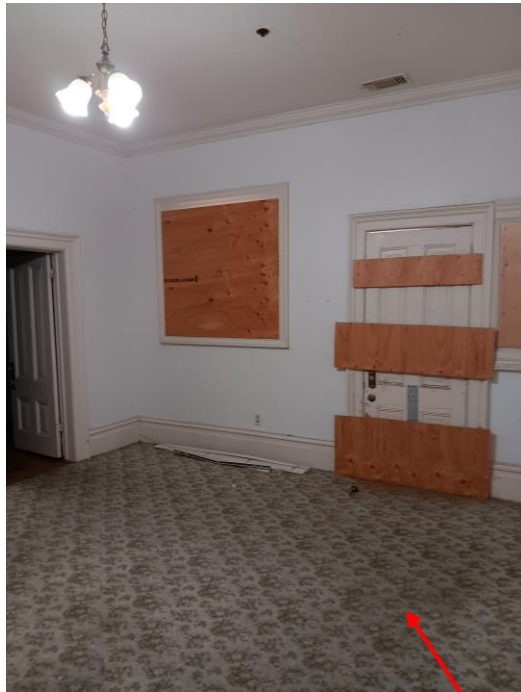
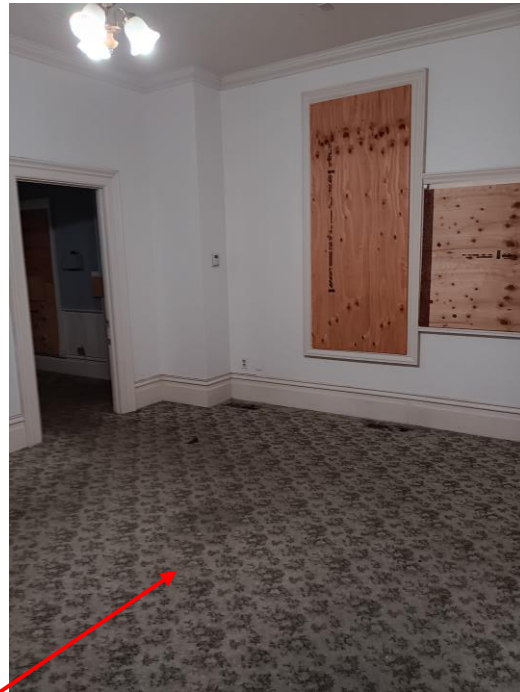
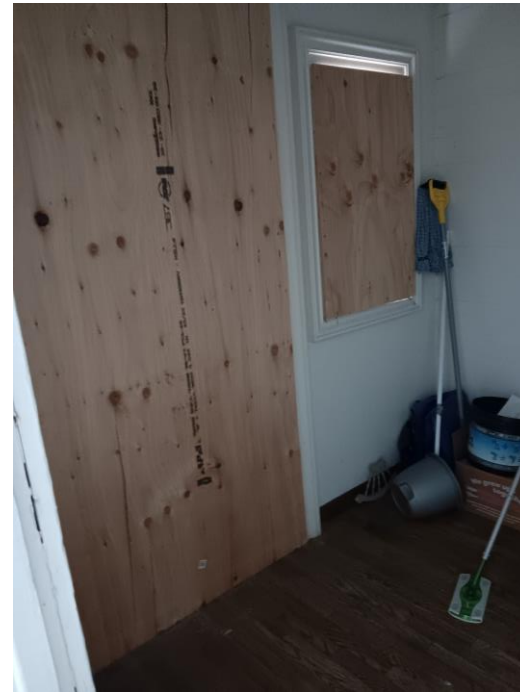
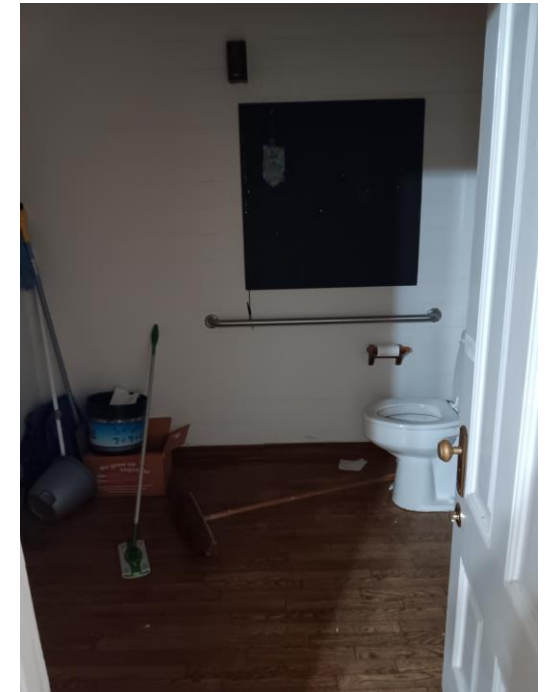
First floor on the left side, Back Room & Bathroom

Water leaks and damaged floors

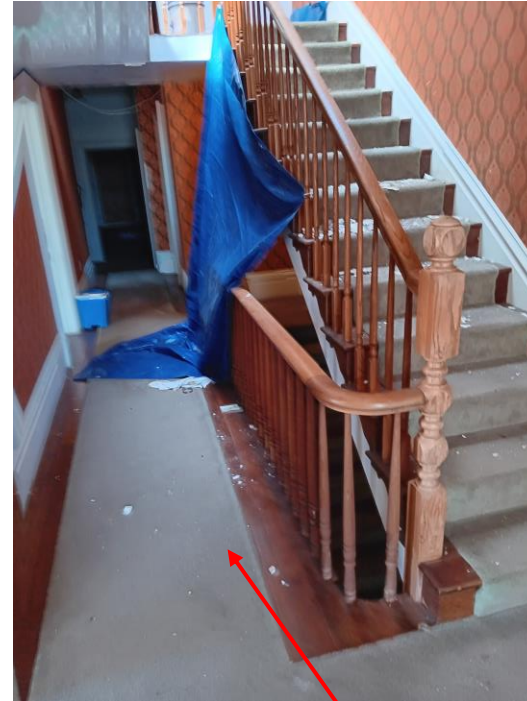
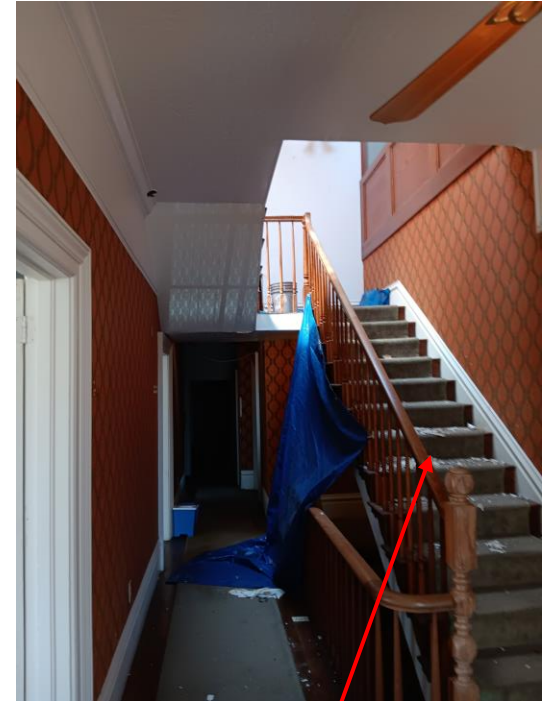
Extensive water leaks & damage in hallway and stairs to
the 3rd Floor from skylight and roof.

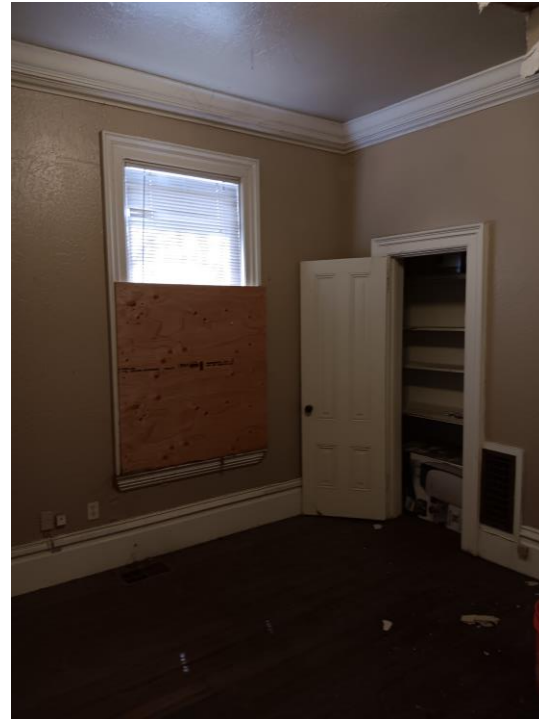
Office 2 (at top of stairs,
middle) has water leaks
and ceiling damage

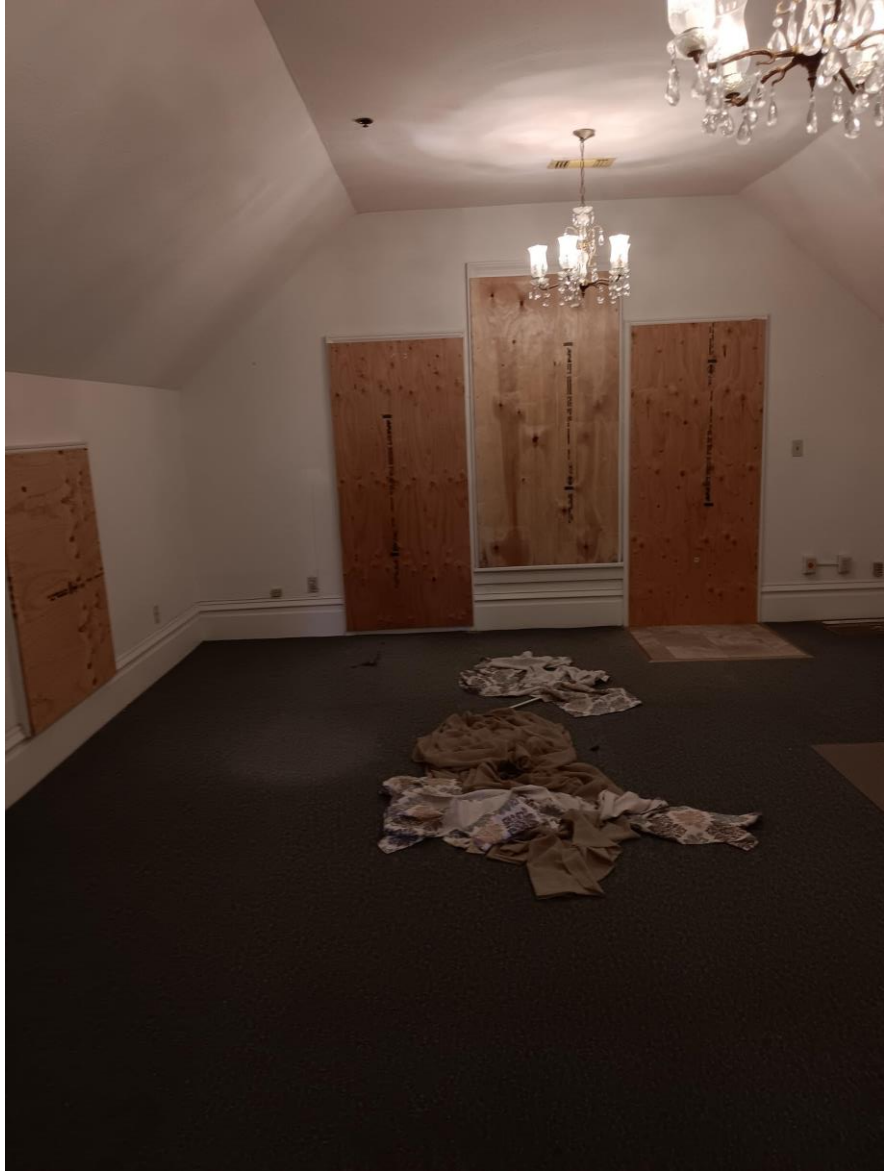
Water leaks and damaged floors

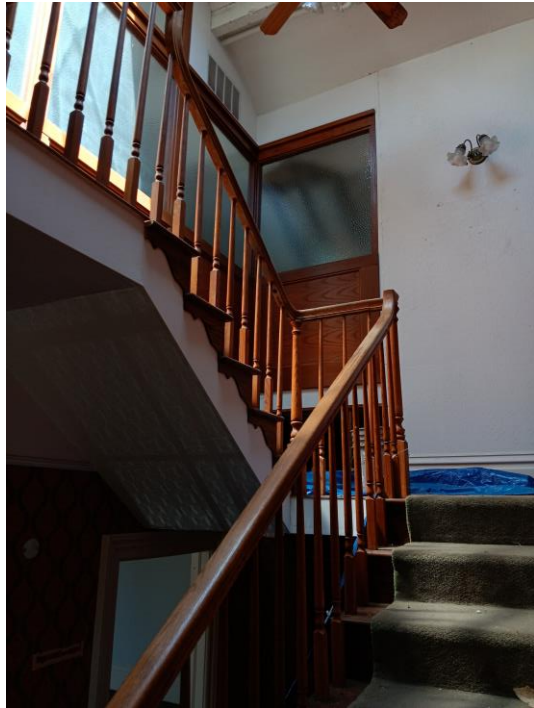
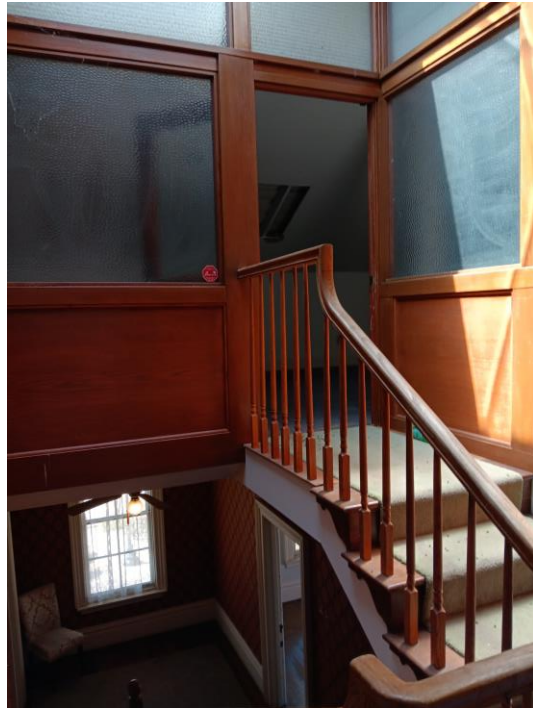
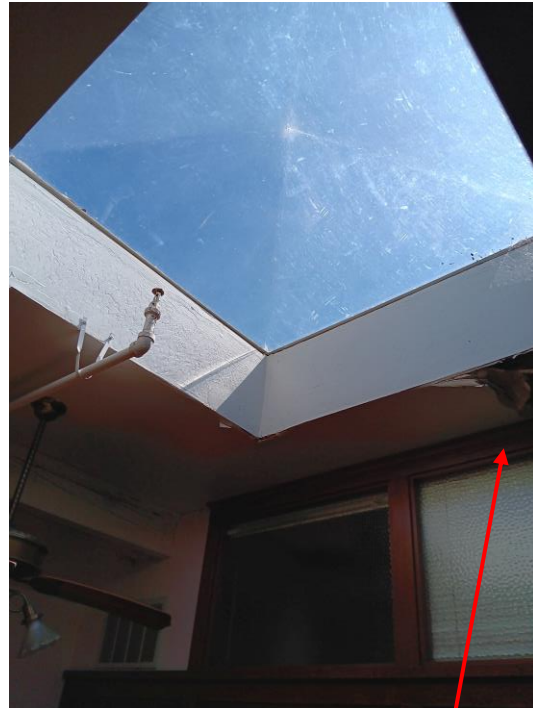
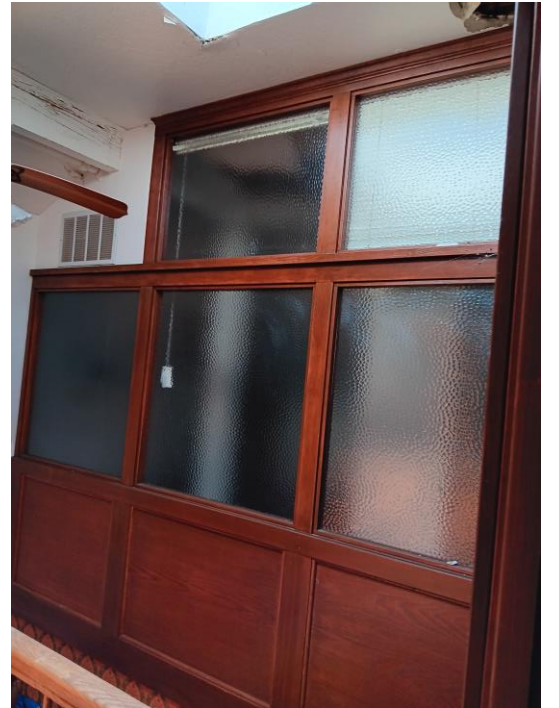
Third Floor Stairs, Landing and Skylight

Leaking and extensive water damage

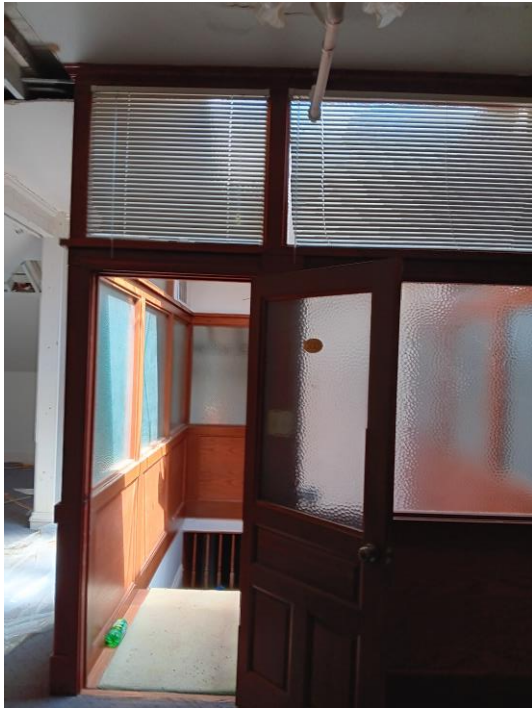
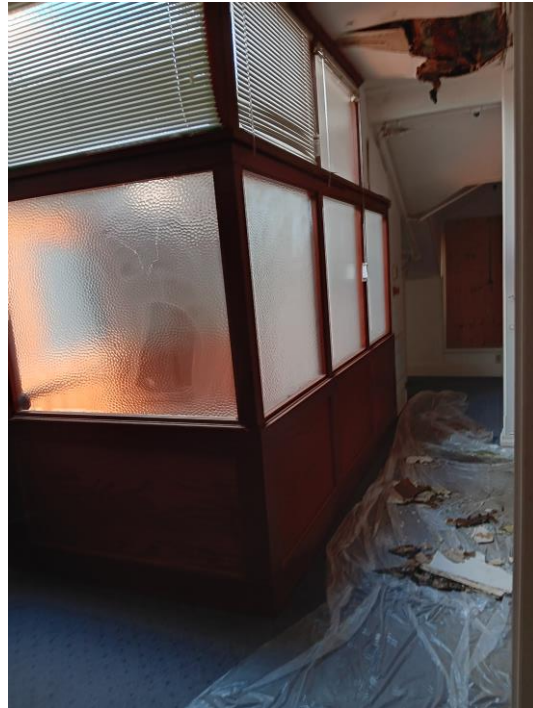
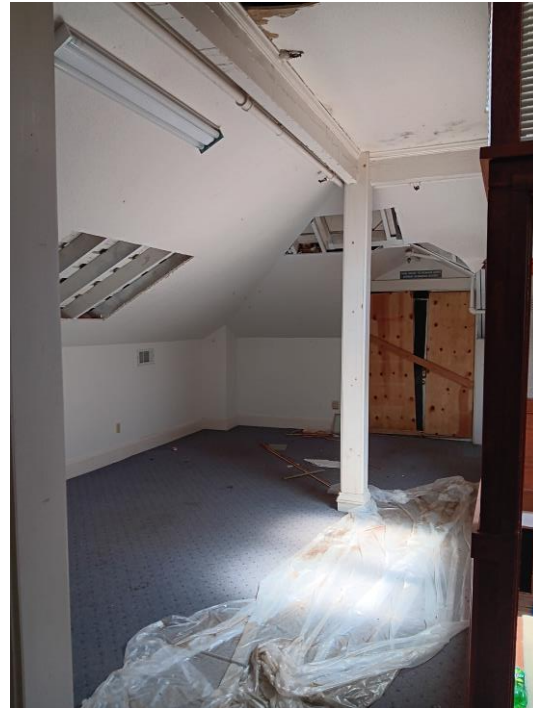
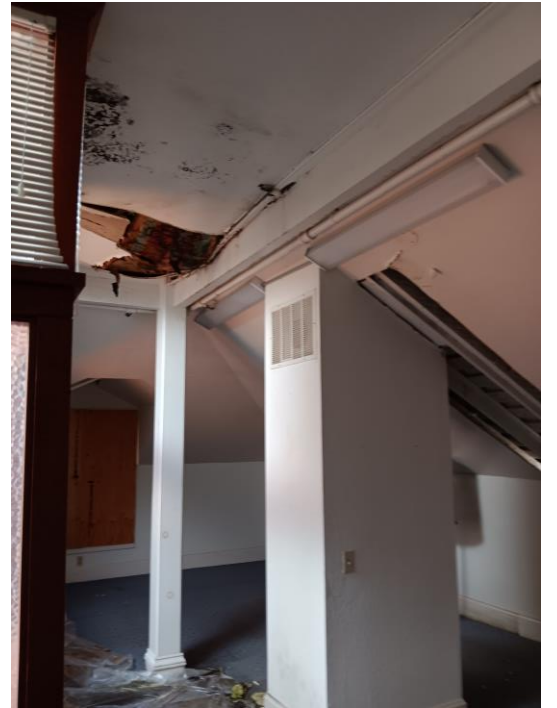
Third Floor Attic Space – To Back of Building

Extensive water leaking & mold

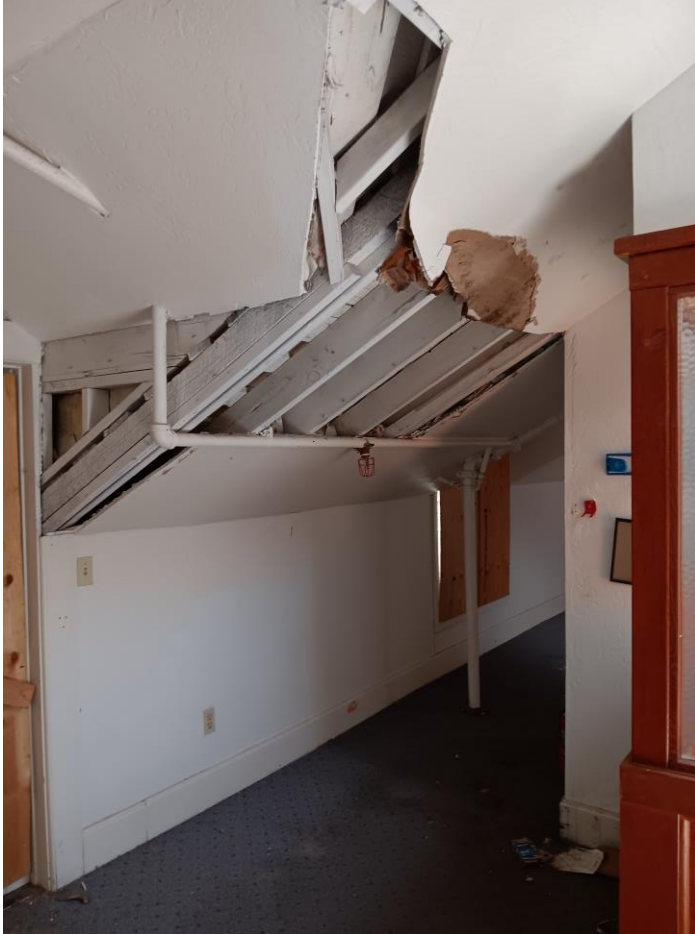
Third Floor Attic Space – To Front of Building

Water Damage on ceiling

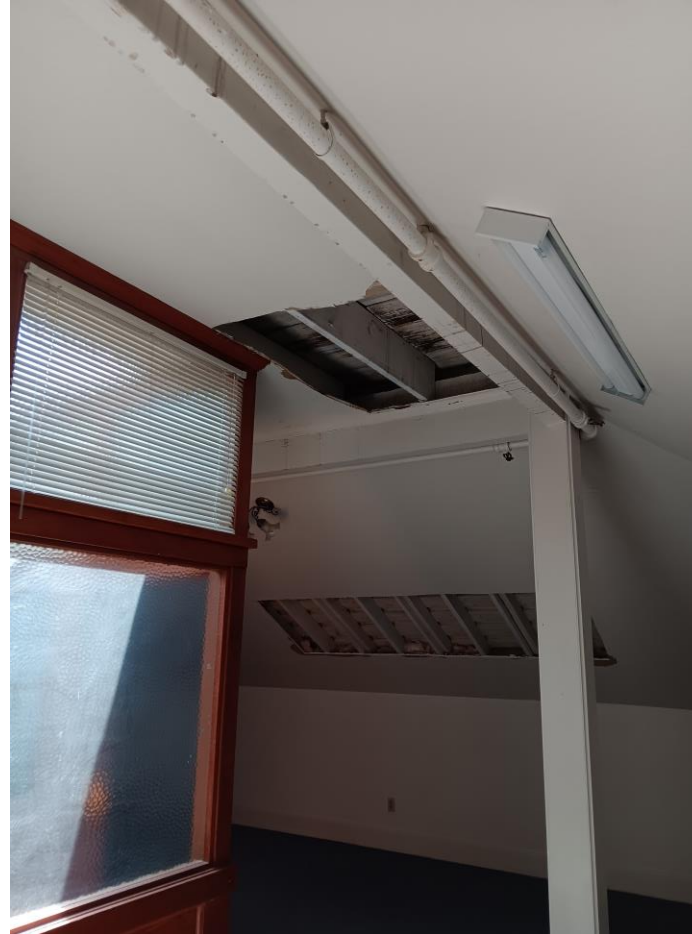
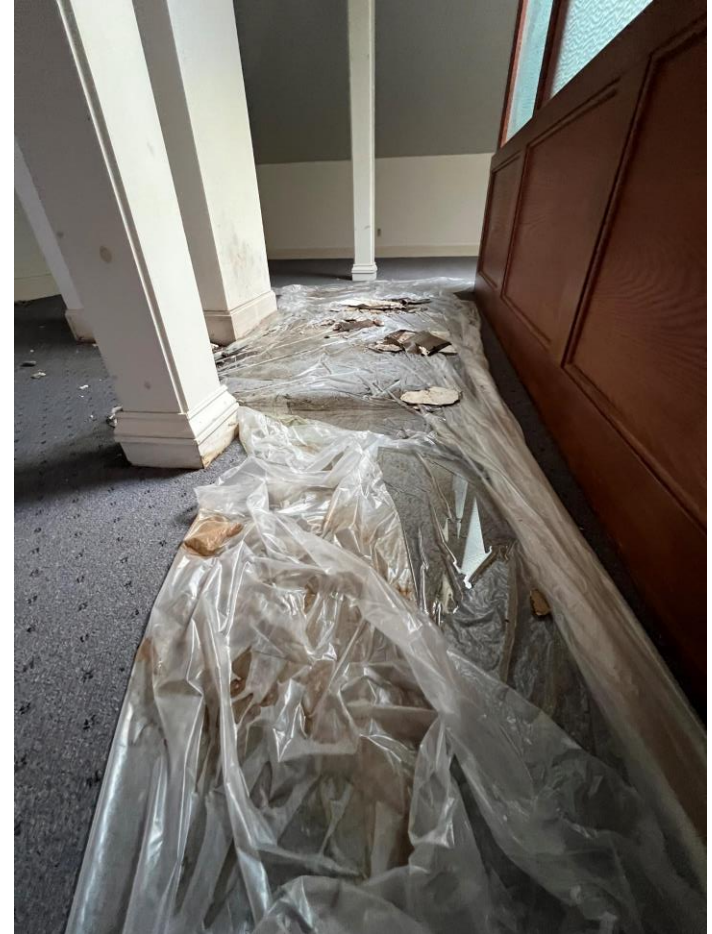
Flooding from roof leaking

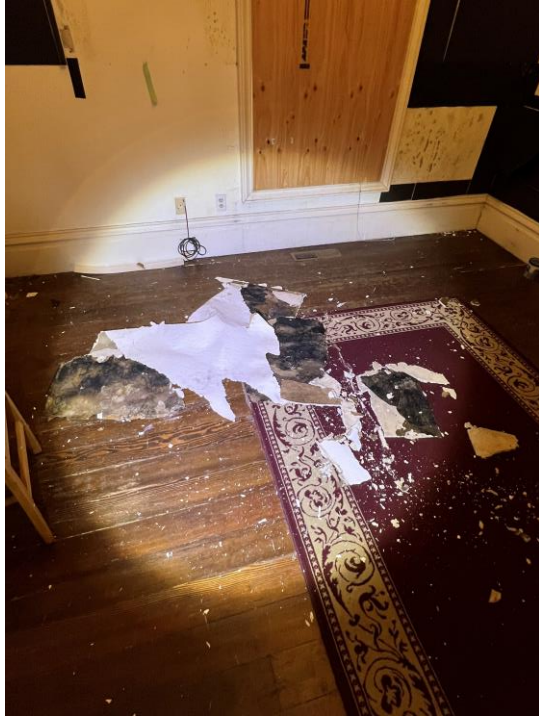
Museum Office Back Room: water leaking & mold. Water is coming from the roof to first floor

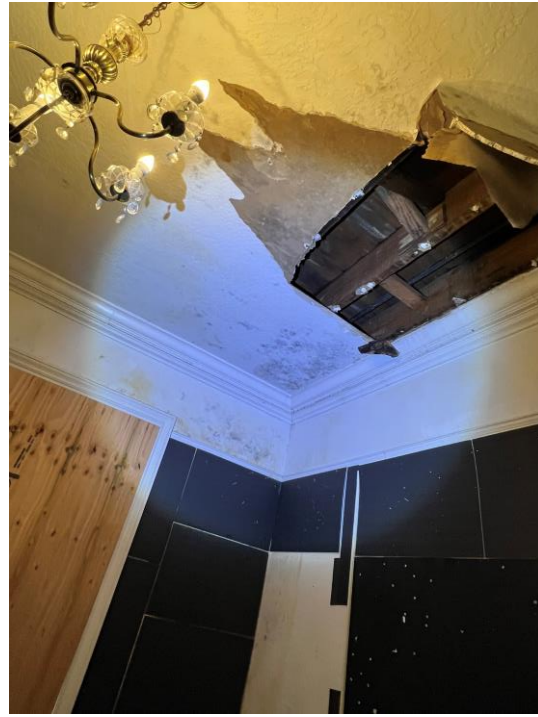
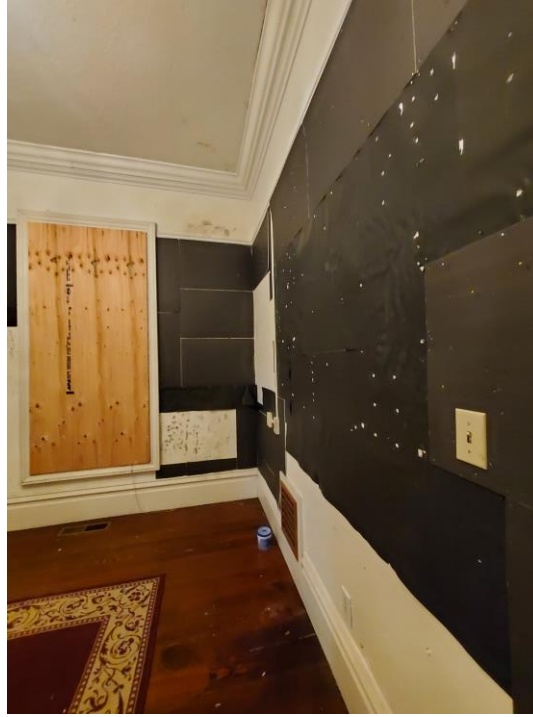
Museum Office Front Room: mold

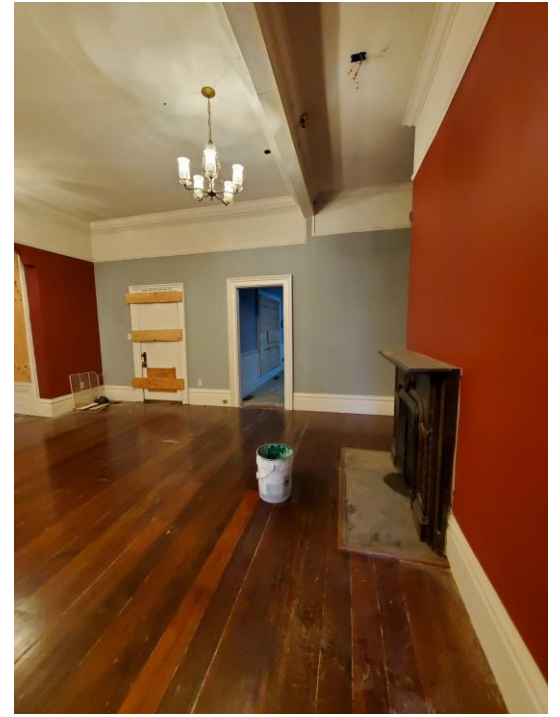
Art Gallery Front Room: water leaking from beam, damaged floor

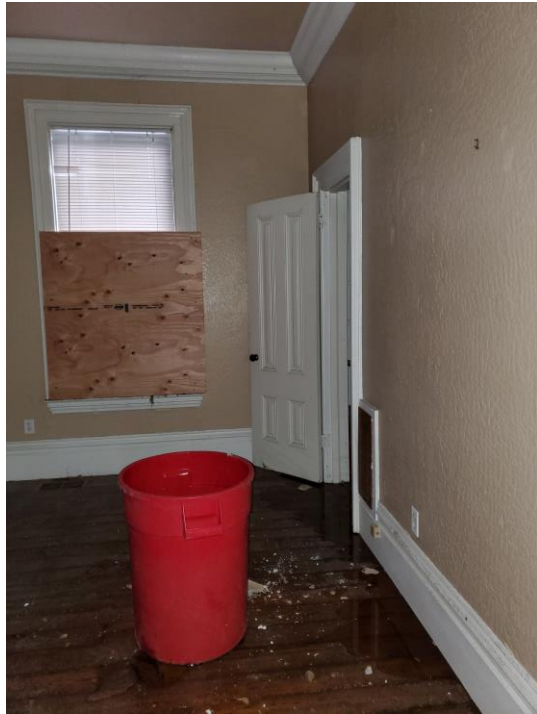
Office off stairs: Water damage and mold from roof leaks

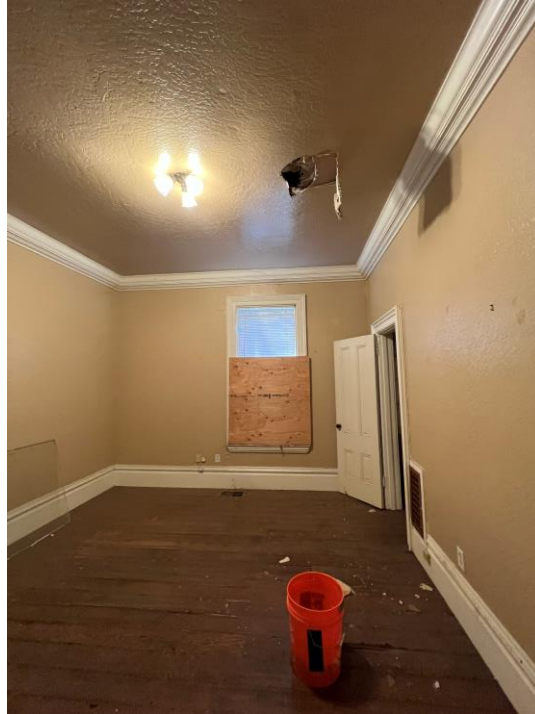
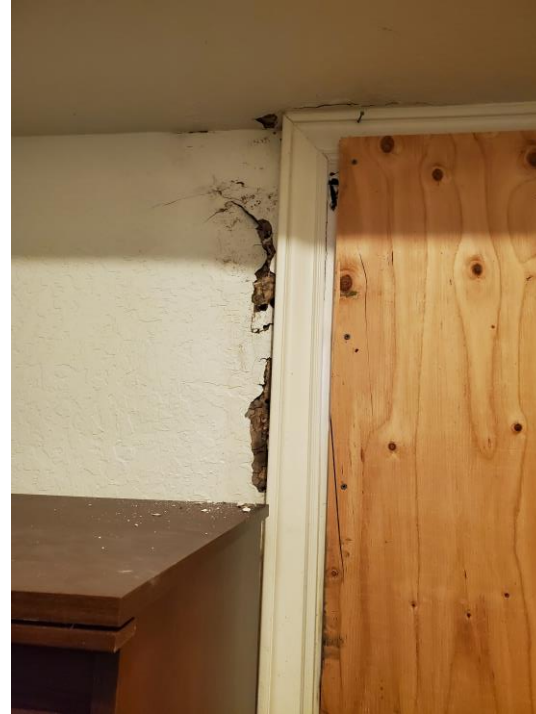
Hallway: Water damage

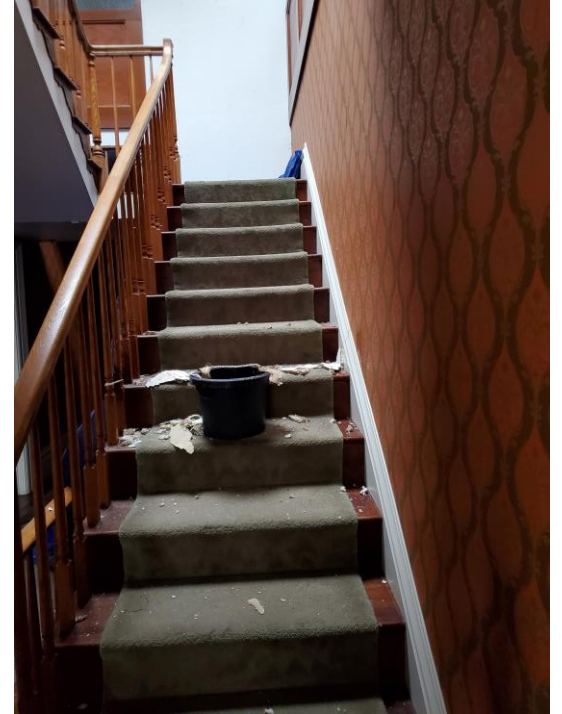
Stairs to 3rd Story: Water leaks from skylight and fallen ceiling

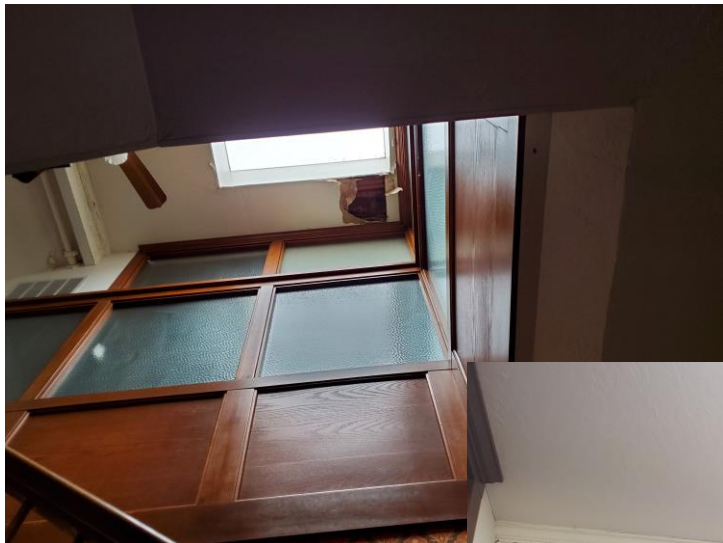
Water Damage on ceiling and beam

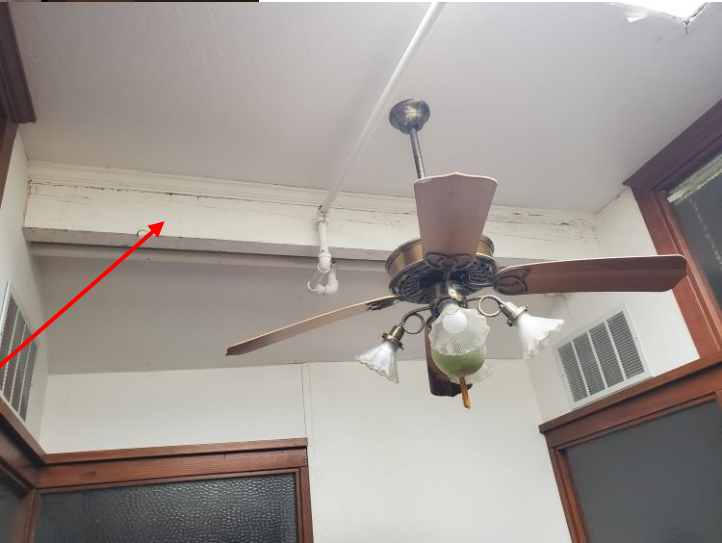
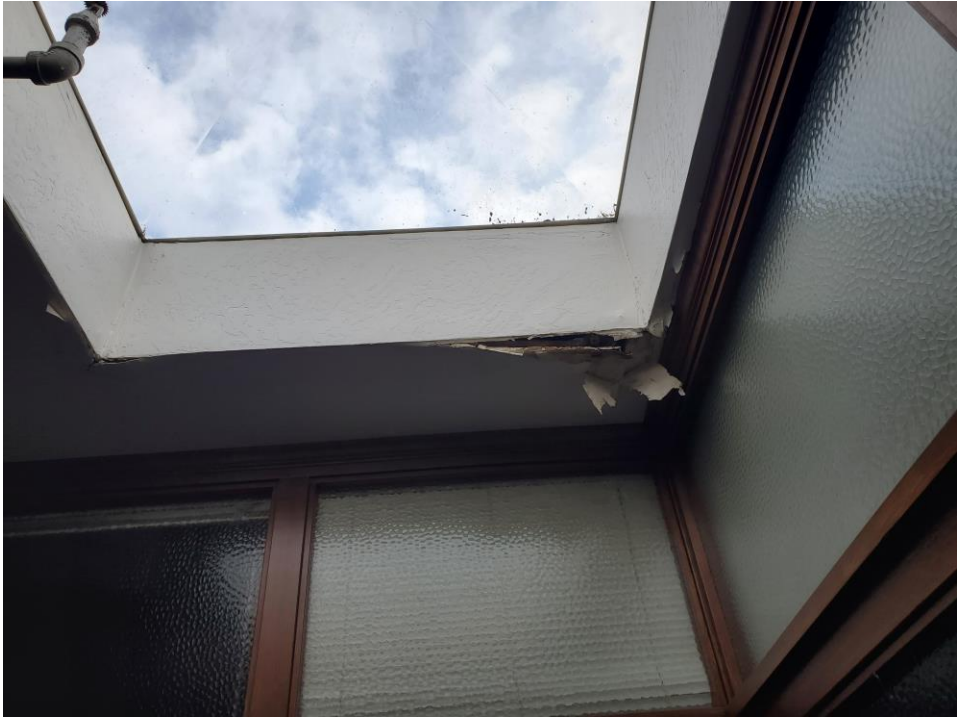
Leaking skylight with damaged ceiling

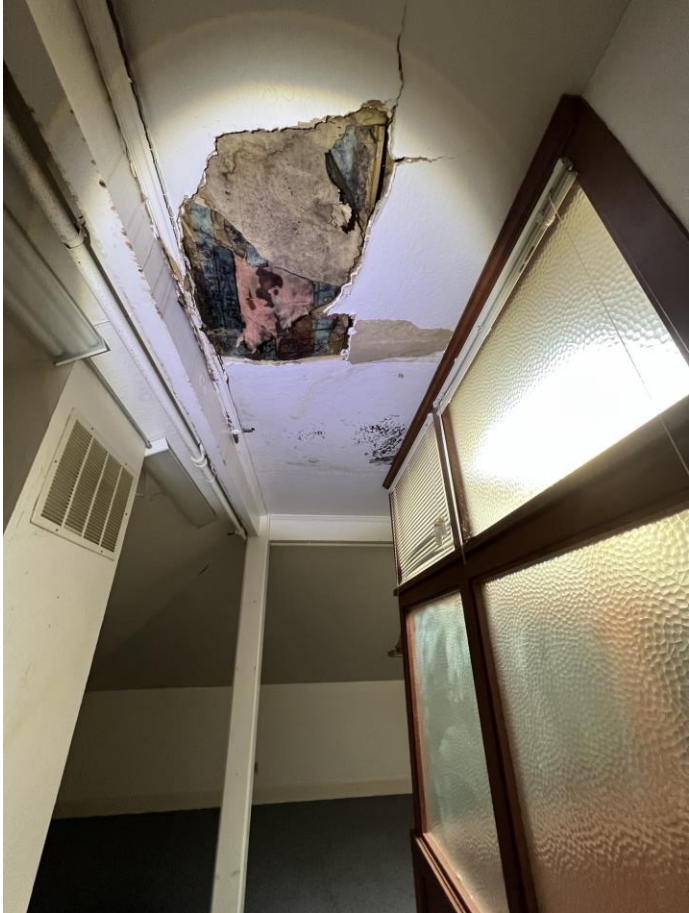
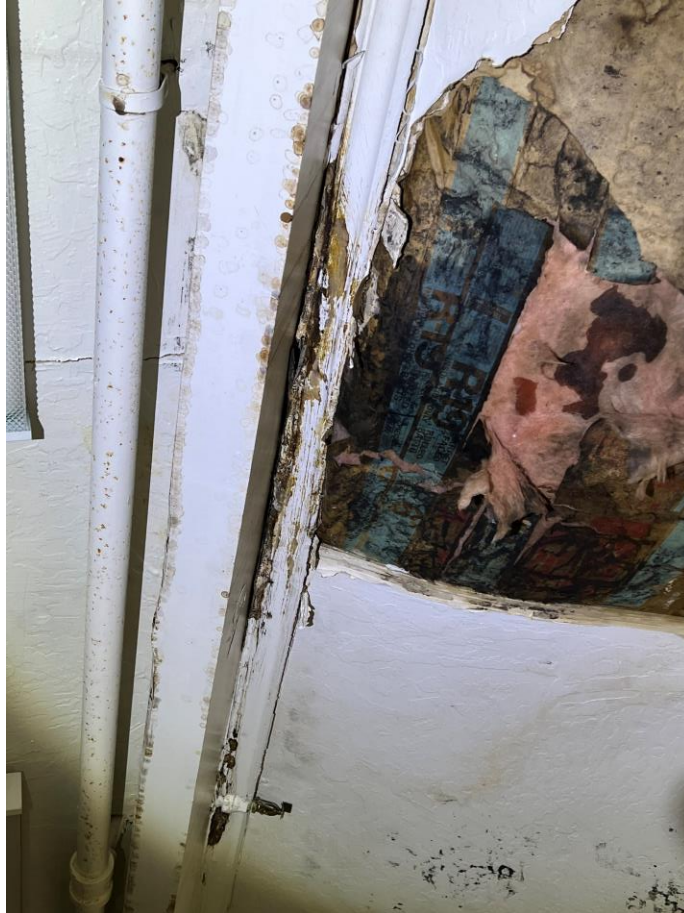
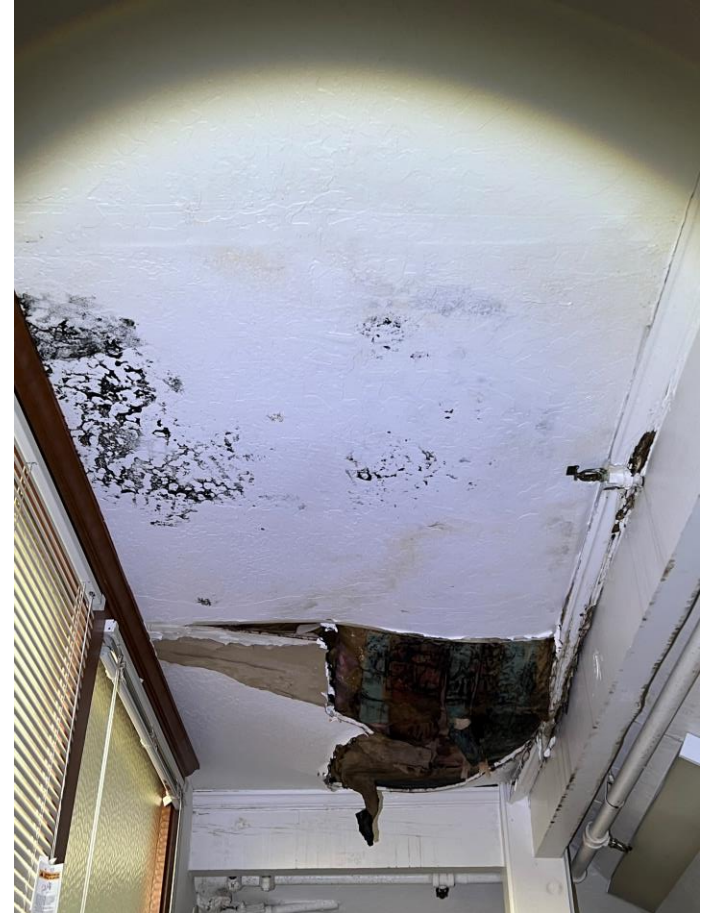
Current Conditions: Third Floor Attic Space Extensive Mold & Water Damage

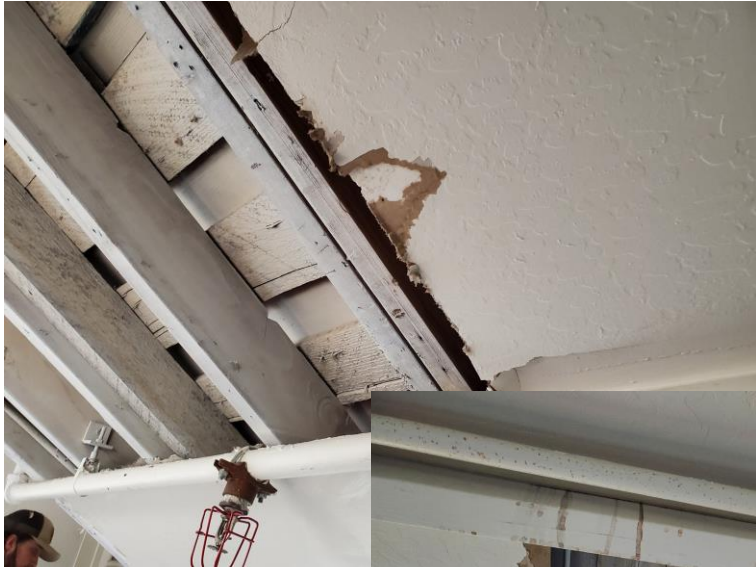
Attic Space
water damage
under roof

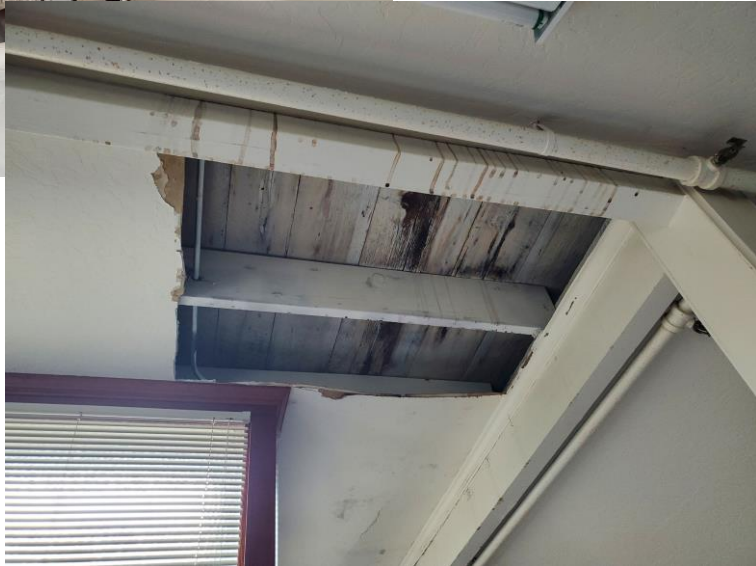
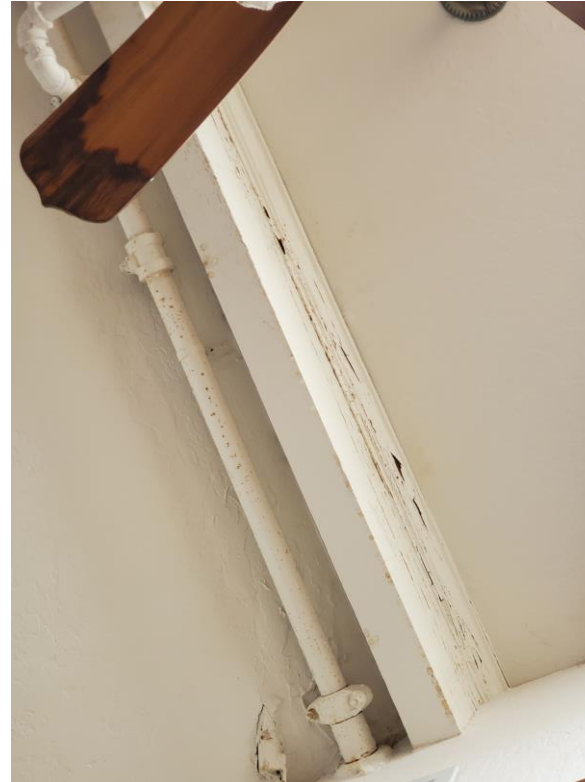
Roof beam water damage

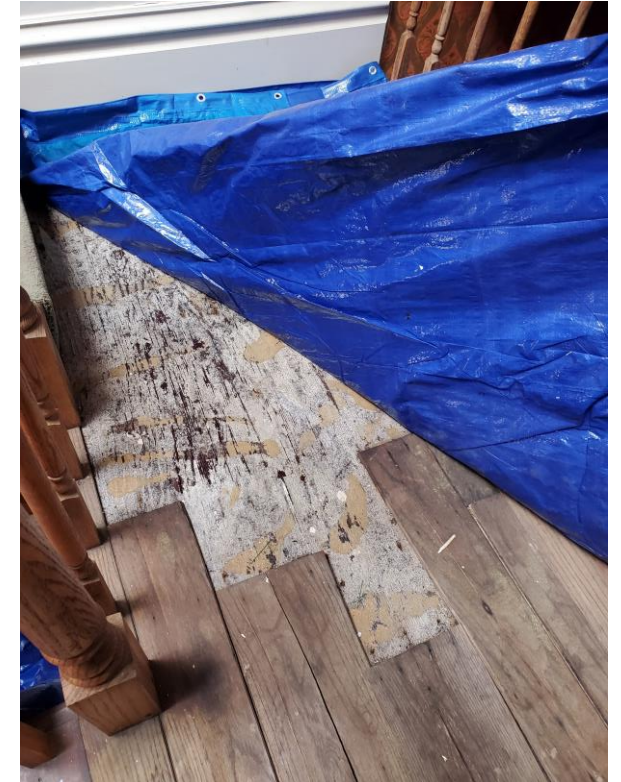
3rd Story Landing: Water
damage & mold
