Accessibility Report

City of Suisun City Senior Citizen Center

318 Merganser Drive
Suisun City, CA 94585

Date of Inspection
1/14/2021

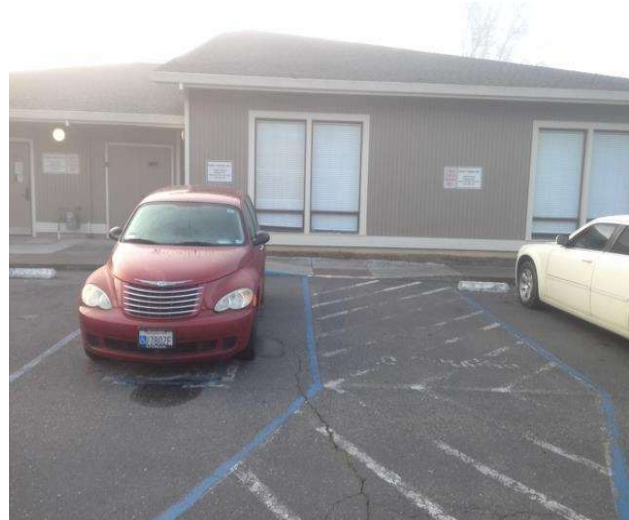
North Accessible Space

Parking : Access Aisle Slope

The slope of the access aisle is not compliant.

On-Site Finding 2.40 percent

Repave the access aisle to provide a compliant surface slope.

Recommendation Up to 2.08 percent

Repave surface to correct slope \$3,800
and re-stripe

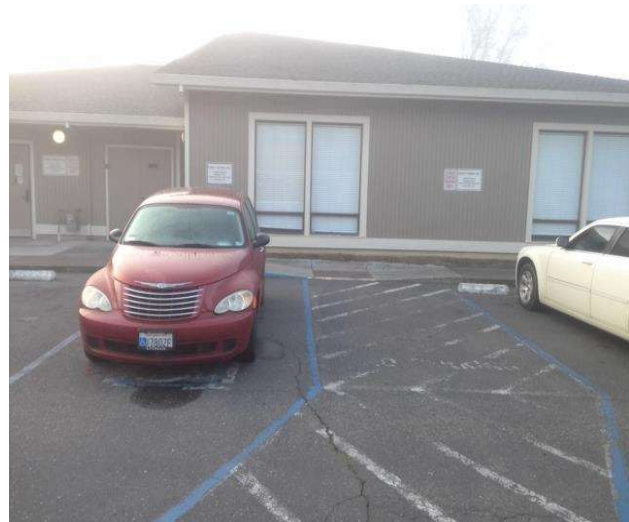
North Accessible Space

Parking : Access Aisle is Faded or Damaged

The access aisle markings are faded, damaged, or otherwise not viewable.

Re-stripe the access aisle so as to discourage parking.

Re-stripe existing parking space \$250

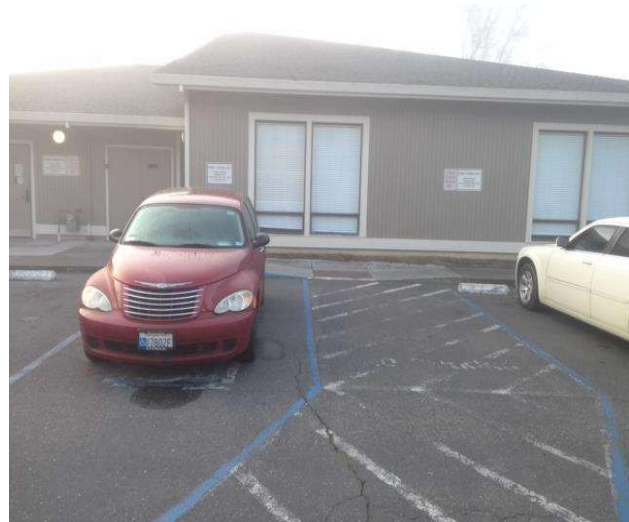
North Accessible Space

Parking : Parking Lot Warnings

There is no minimum fine sign at the parking space.

Provide a minimum fine sign at the parking space below the International Symbol of Accessibility.

Install signage \$300

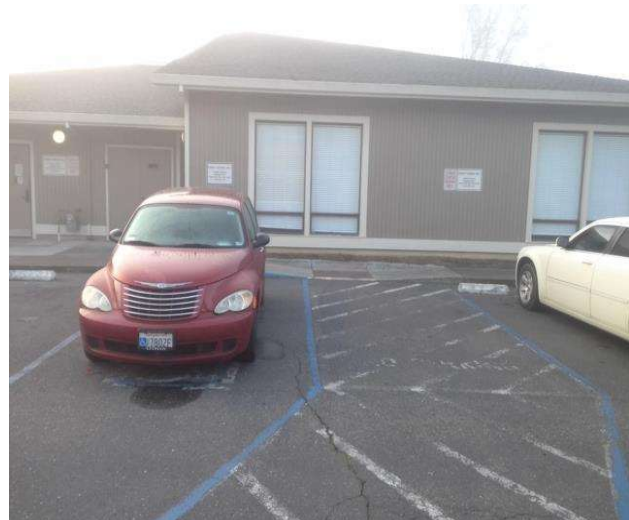
North Accessible Space

Parking : Accessible Signage

There is no signage posted at the accessible parking space showing the International Symbol of Accessibility.

Provide compliant signage at the accessible space.

Install post mounted sign \$250

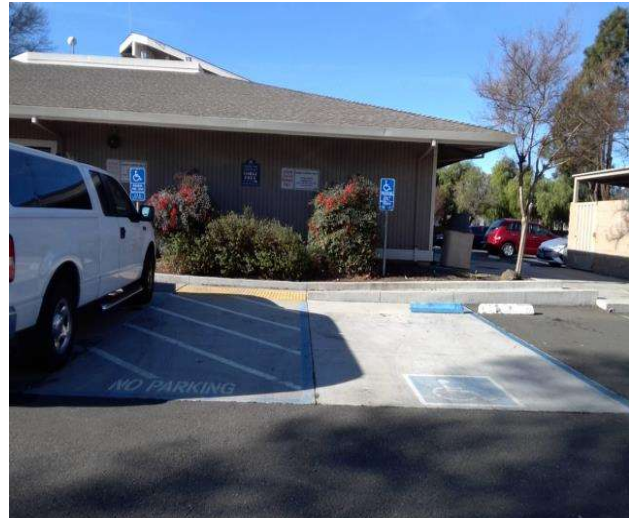
Right Accessible Space Next to Main Entrance

Parking : Parking Space Accessible Signage Height

The bottom edge of the post-mounted signage designating the accessible parking space is not at the required height.

On-Site Finding 58.75 inches

Post signage at a compliant height.

Recommendation At least 60.00 inches

Modify or replace post mounted \$158
sign
