**PHASE I ENVIRONMENTAL SITE ASSESSMENT
OF
CRYSTAL SCHOOL
100 Cordelia Street
Suisun City, Solano County, California
For
MAIN STREET WEST PARTNERS**

30 May 2006

SUBSURFACE INVESTIGATION REPORT

**FORMER CRYSTAL MIDDLE SCHOOL
SUISUN CITY, CALIFORNIA**

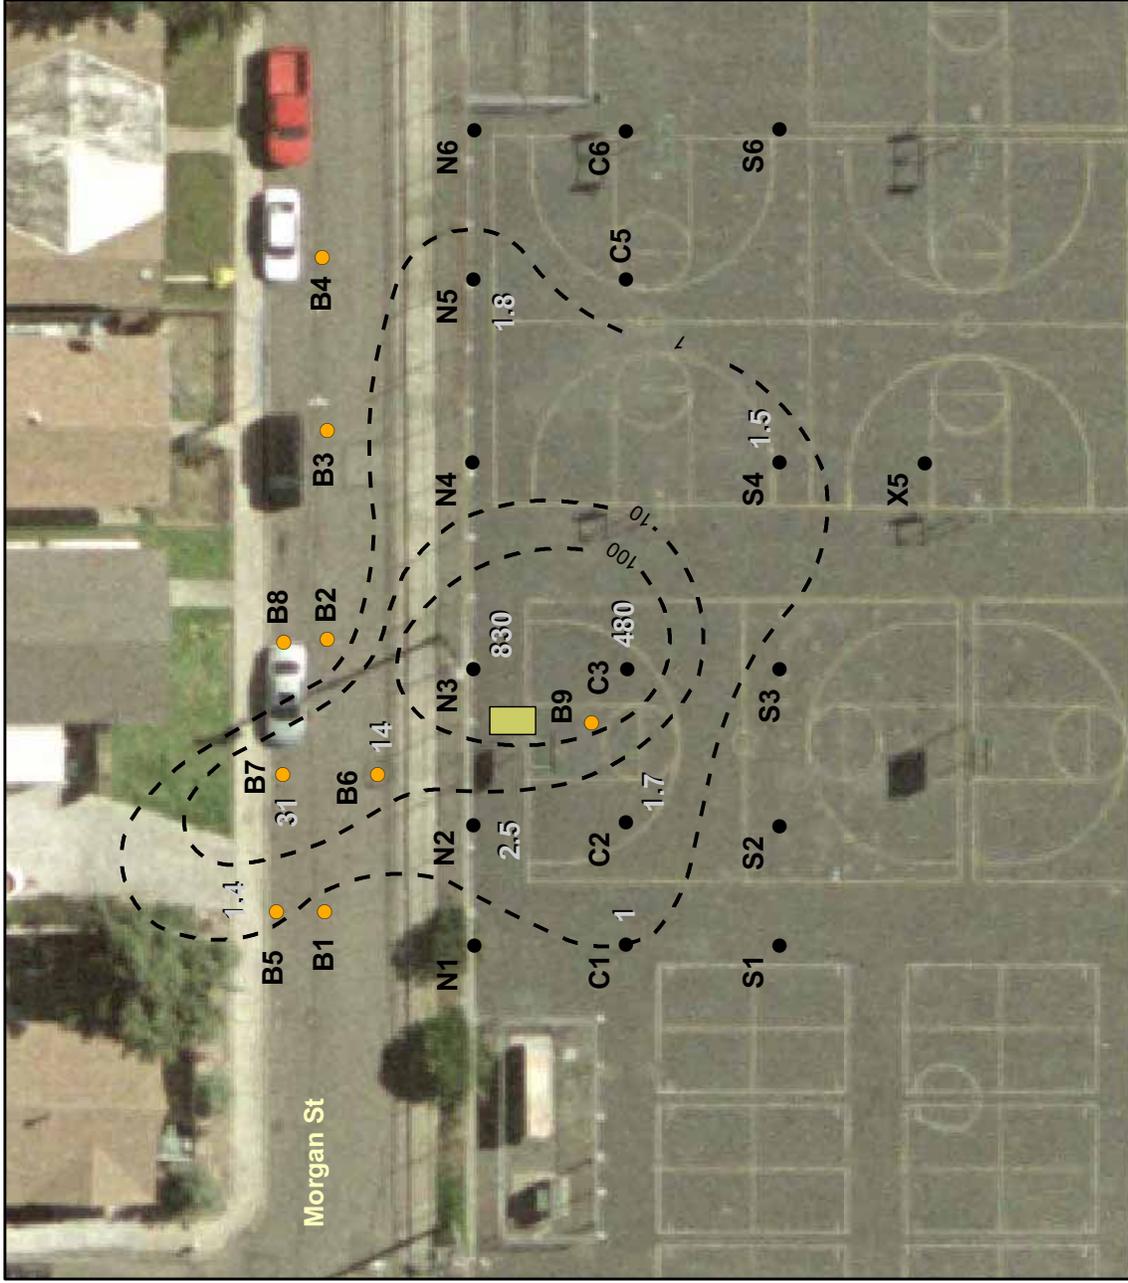
- Test Pit Sample Locations
- Marked Boring Locations
- Apx. Former Tank Location
- - - Equal Line of TPHd Concentration
- 480 TPHd Concentration in mg/kg

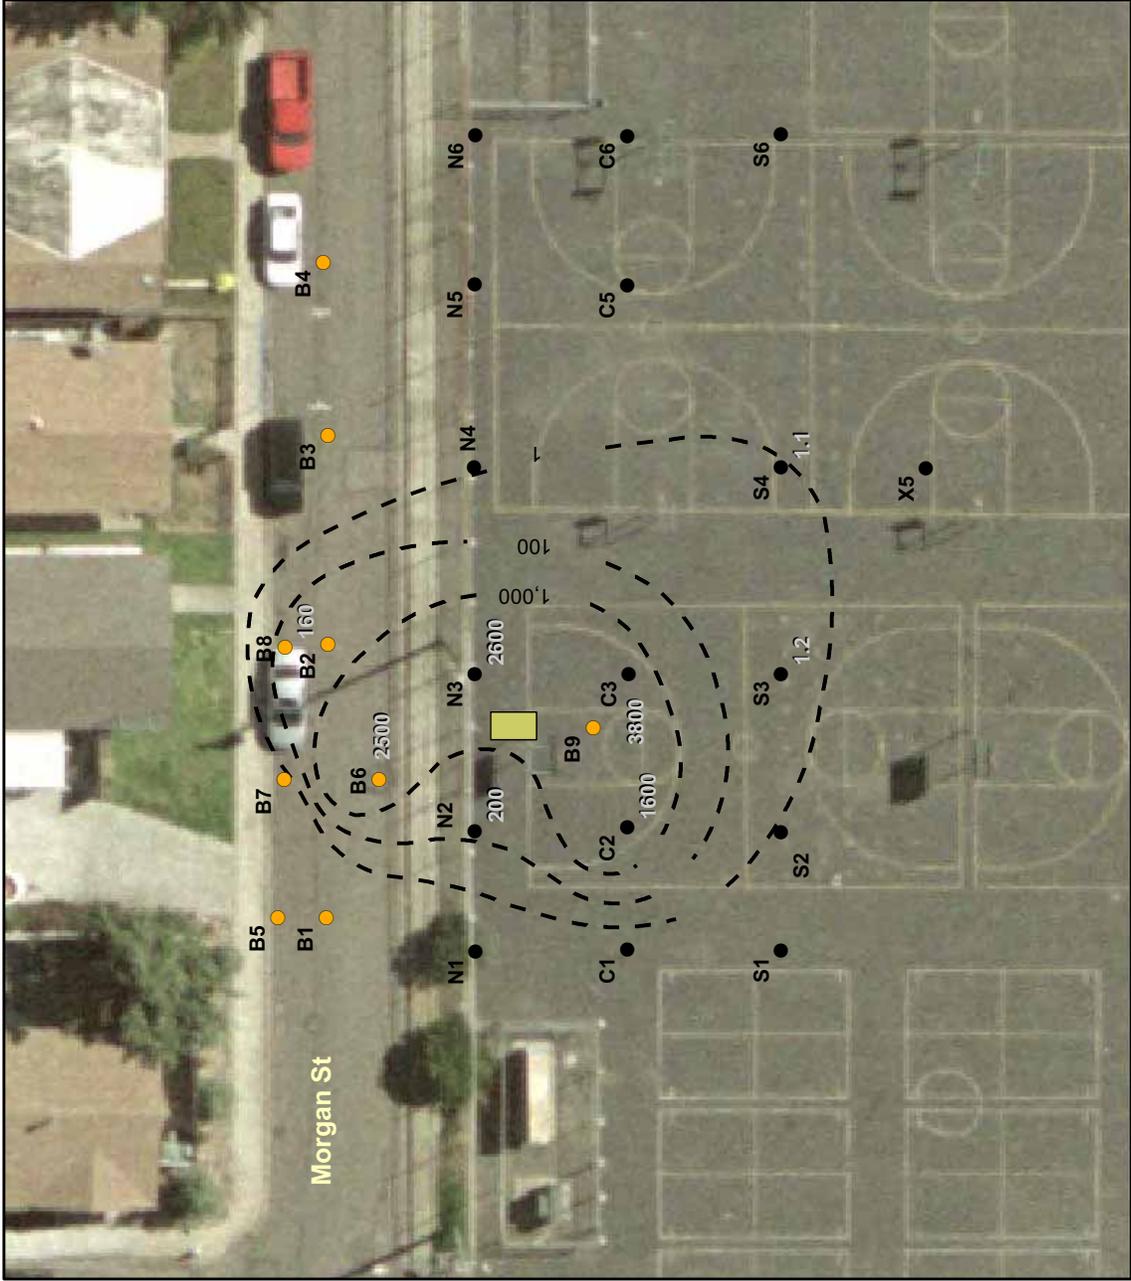
- Test Pit Sample Locations
- Marked Boring Locations
- Apx. Former Tank Location
- - - Equal Line of TPHd Concentration
- 1.1 TPHd Concentration in mg/kg

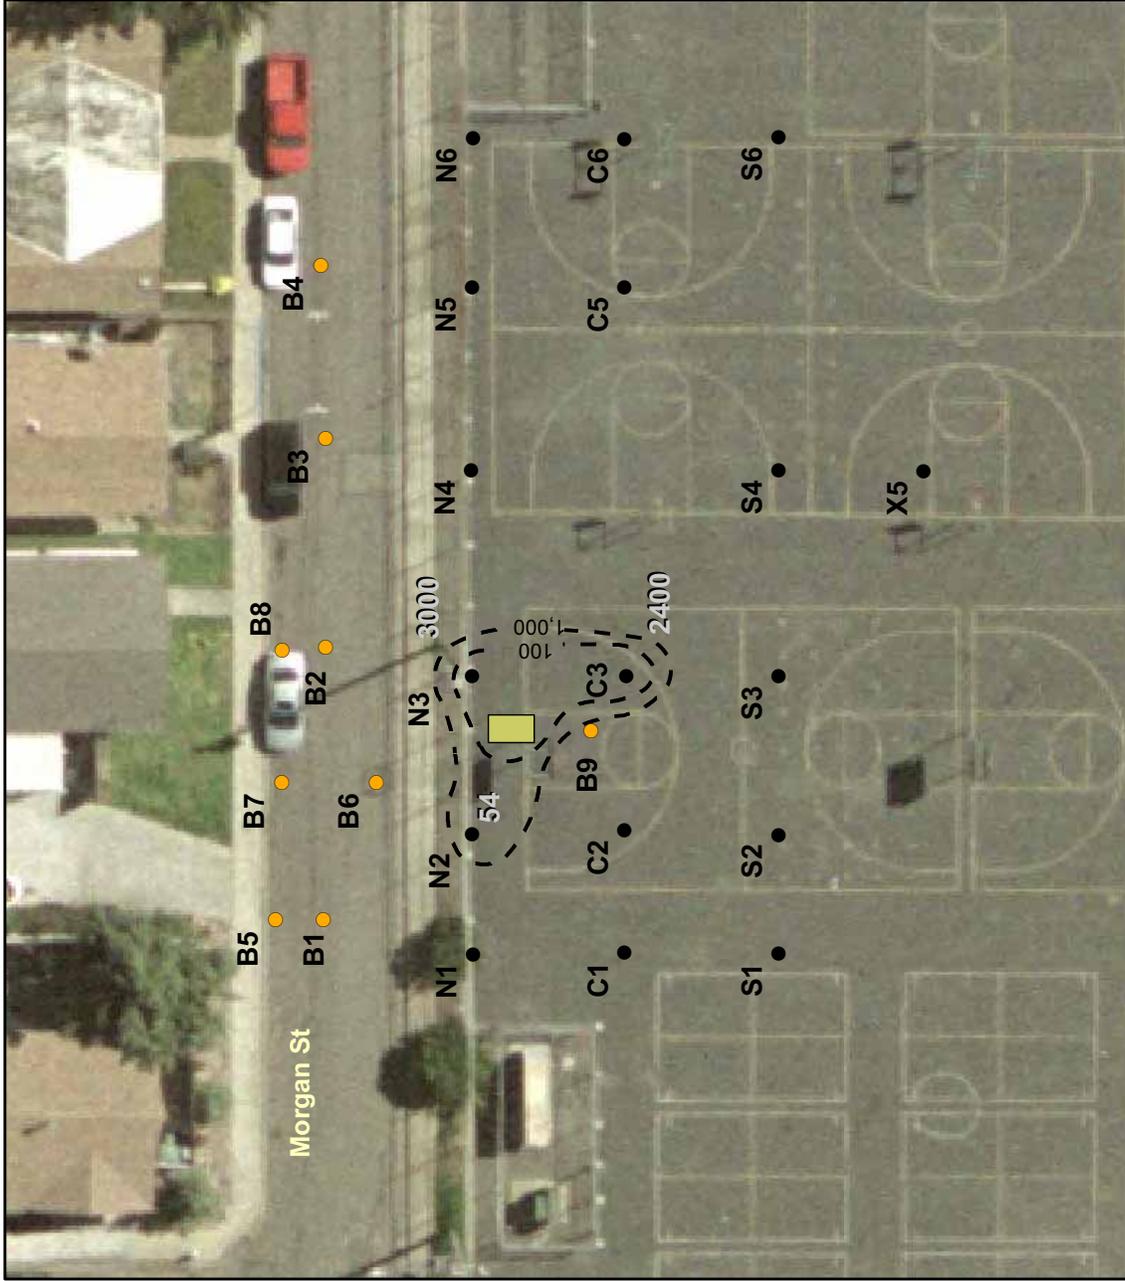
- Test Pit Sample Locations
 - Marked Boring Locations
 - Apx. Former Tank Location
 - - - Equal Line of TPHd Concentration
- 54 TPHd Concentration in mg/kg
