CONTINENTAL APARTMENTS

1101 Crystal Street, 1117 School Street & 1101 West Street
Suisun City, California 94585

Attached please find *Basis Architecture & Consulting Inc.'s (BASIS), PHYSICAL NEEDS ASSESSMENT* (the *Report*) for the above-mentioned asset (the *Property*). During the property investigation and research, *BASIS'* property surveyor met with agents representing the *Property*, or agents of the owner, and reviewed the property and its history. The *Report* was completed according to the terms and conditions authorized by you.

Continental Apartments, Suisun, CA
Conditions as of: November 13, 2012

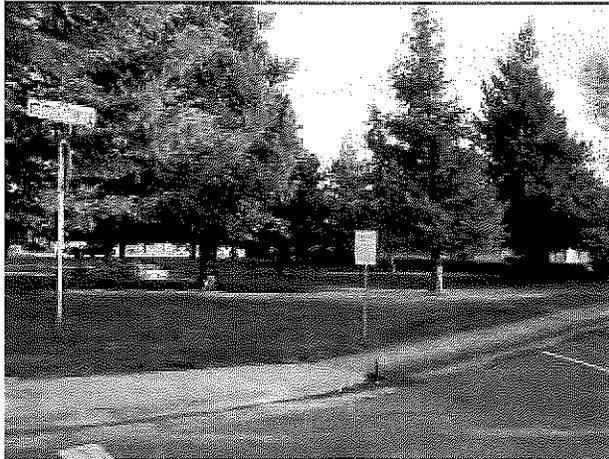
1. Open area at north perimeter of Crystal Street building

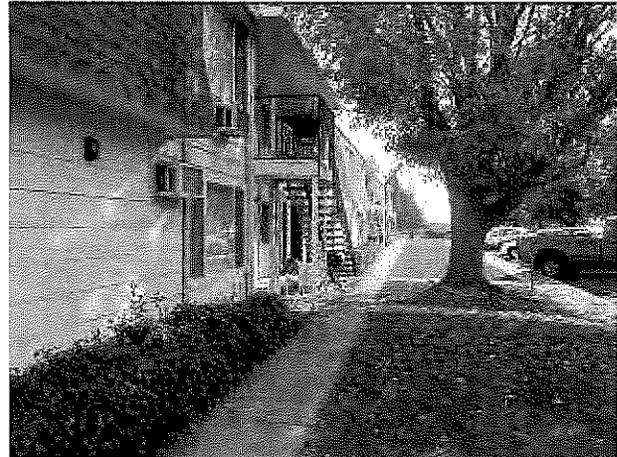
14. Typical landscaping, walkways, and building finishes

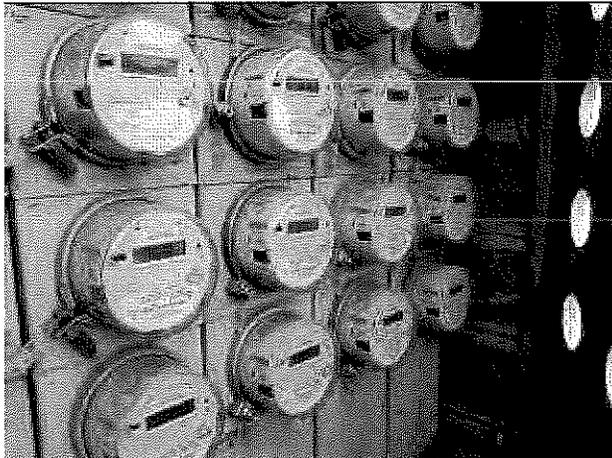
33. Individual electric meters

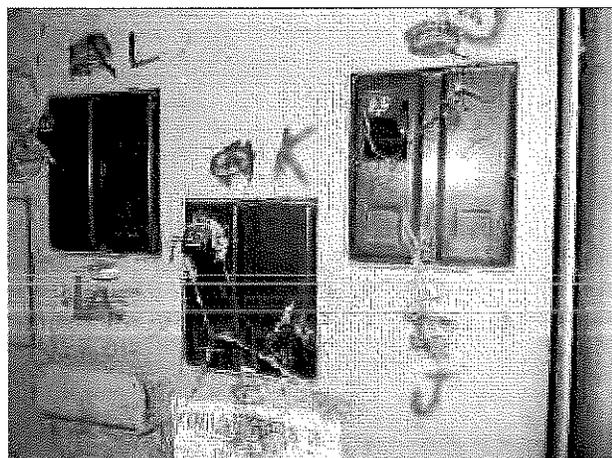
35. 50 amp main breakers for unit electrical meters

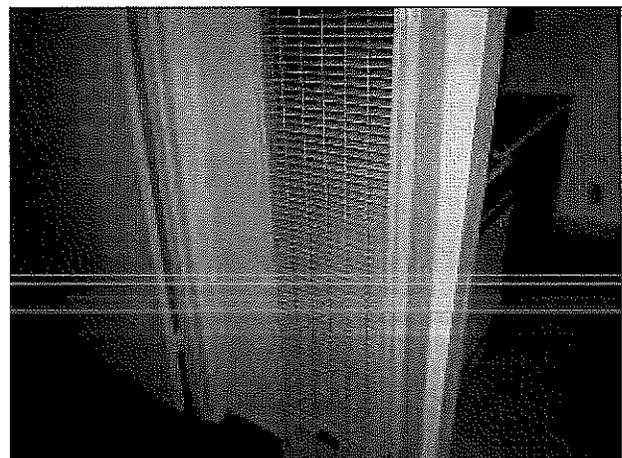
36. Gas fired wall heaters for unit heating

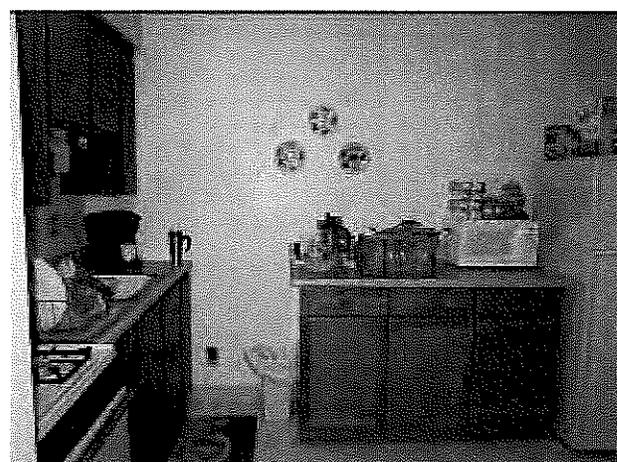
42. Kitchen with older and newer cabinets

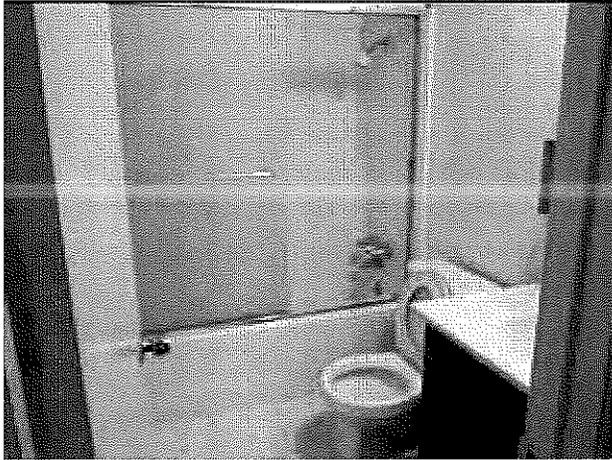
43. Bathroom finishes
